**FA-2024-056: Nota urgente sulla sicurezza  
Correzione per il tavolo operatorio TruSystem 7000**

| Question or Item | Answer |
|---|---|
| Subject | TSB TruSystem battery exchange |

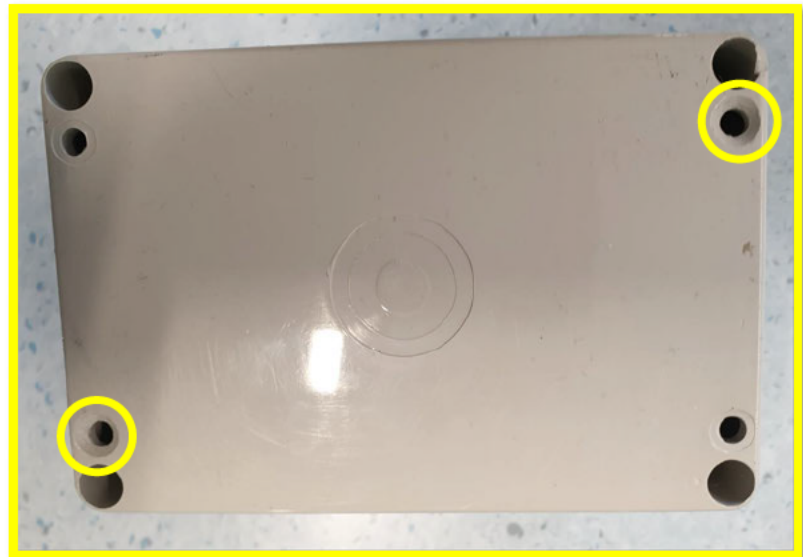
1. Installation situation of the battery (underside with holes for the positioning pins):

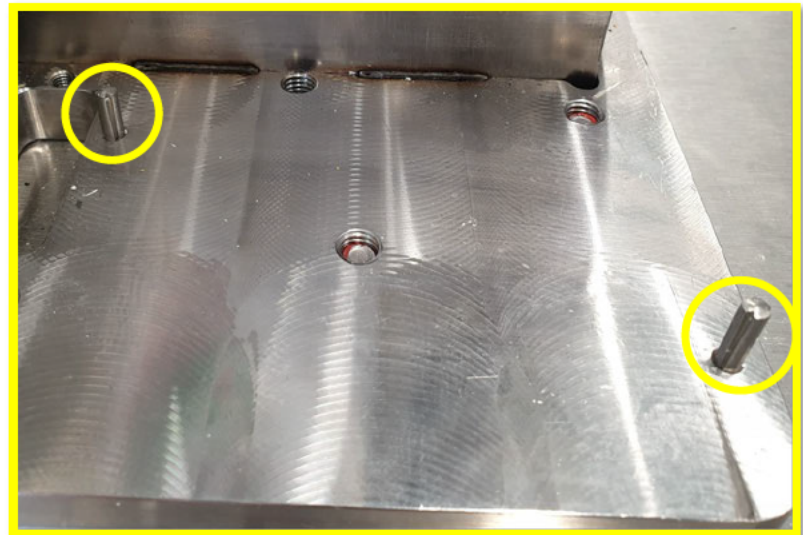
2. Installation situation TS7500/TS5500 (power supply side, without pot), positioning pins:

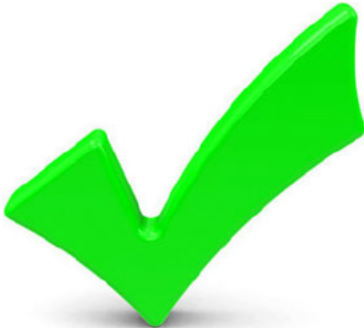
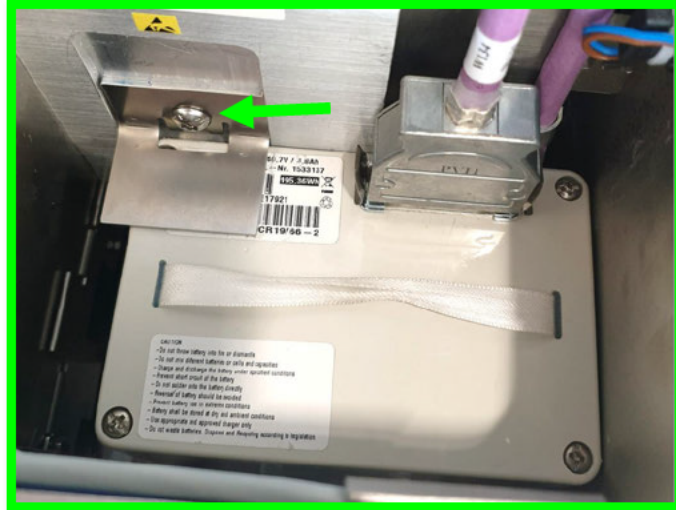
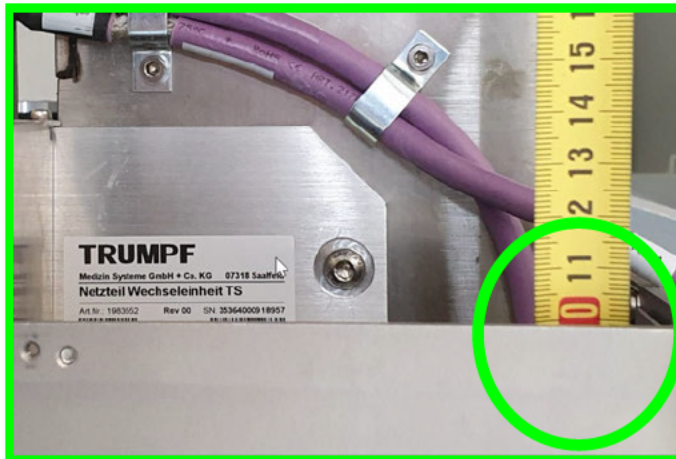
3. Battery correctly mounted in TS7500/TS5500 (power supply side) battery mounting bracket is installed correct, battery is flat on bottom of column, distance correct:

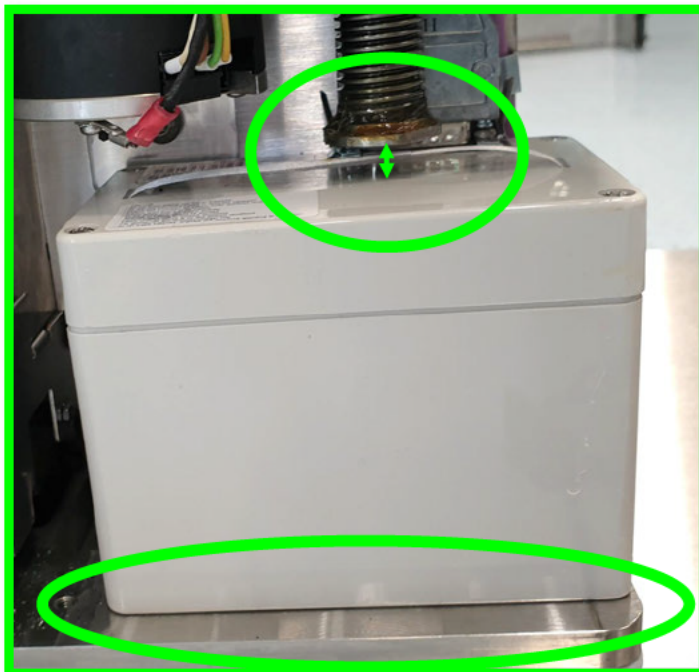
4. Lowest position of main lift incl. additional lift TS7500/TS5500 (without pot) when correctly mounted (distance between spindle and battery approx. 8mm, battery is flat on bottom of column):

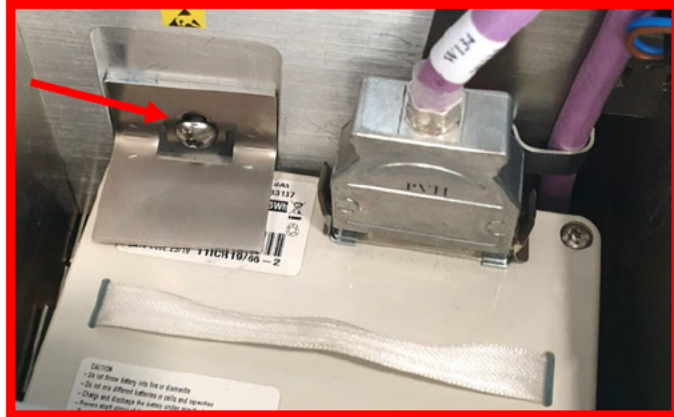
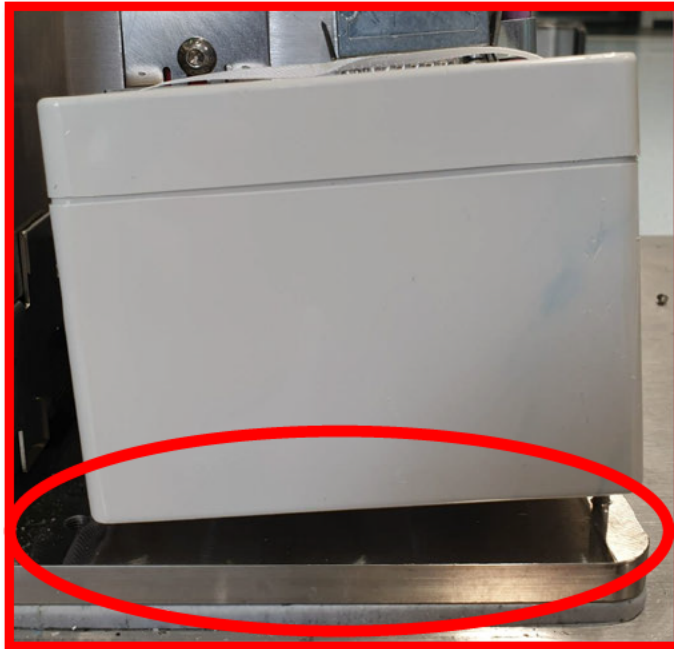
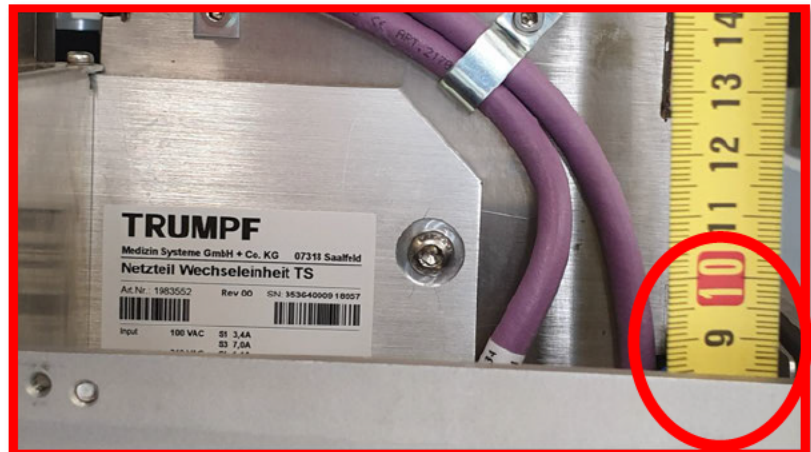
| <p>Issue details</p> | <p>When replacing the rechargeable batteries, Mat.1533137 or Mat.2066802, it is important to ensure the correct positioning of the batteries in the operating table.</p> <p>If the batteries are not placed correctly, the batteries or the battery plug may be damaged by the spindles of the tilting motor in the lowest column position.</p> <p><u>A damaged Li-Ion battery is a safety risk and must be replaced.</u></p> <p><b>ATTENTION!</b><br/> <b>Failure to follow the instructions in the service manual and as a result an incorrect battery position can lead to a short circuit / smoke development / fire!!!</b></p> |

5. Battery incorrectly mounted in TS7500/TS5500 (power supply side, without pot), battery mounting bracket is installed incorrect, battery is not flat on bottom of column, distance incorrect:

| <p>Solution/Action</p> | <p>TS7000 / TS7000dV:<br/> Instructions from the Service Manual 4990344 Chapter 6 and 18.1 must be strictly followed.</p> <p>TS7500 / TS7500 Hybrid:<br/> Instructions from Service Manual 4990348 Chapter 7 and 20.4 must be strictly followed.</p> <p>TS5500:<br/> Instructions from Service Manual 1681913 Chapter 5 and 13.3 must be strictly followed.</p> <p>The batteries must be seated in the positioning pins provided for this purpose on the base of the column and must sit completely flat on the base of the column.<br/> Furthermore it must be made sure that there are no cables under the batteries.</p> <p>It is mandatory to reassemble the battery mounting bracket and in mobile columns the cable holder in the <u>correct</u> position.<br/> <b>A mounted holder, however, does not mean that the battery is correctly fully seated on the column base.</b></p> <p><b>CHECK:</b><br/> The distance between the top edge of the battery and the top edge of the pot can be measured as a check.<br/> This should be approx. 10cm (see photos) if the battery is installed correct.</p> |

After the batteries have been replaced, the column with the tabletop must be moved to the lowest lift position by the technician (including additional lift!). If there is a noticeable noise, it is imperative that the condition of the batteries is checked again, if they are damaged, replace them.

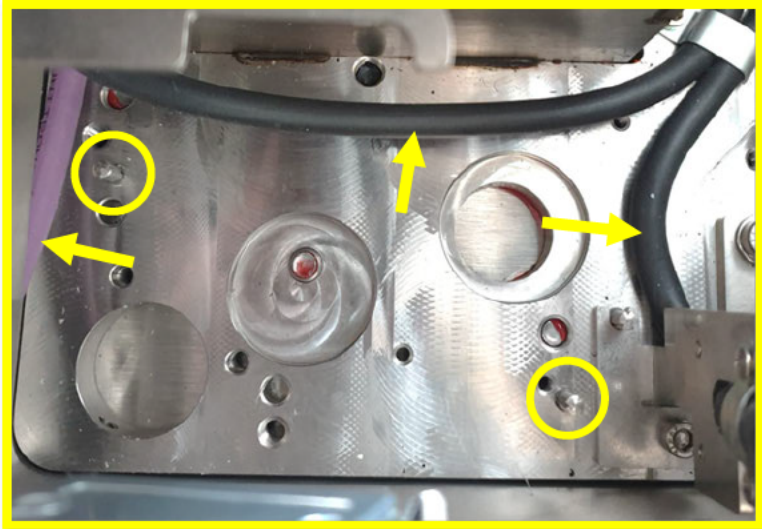
6. Installation situation  
TS7500/TS5500 (motor side,  
mobile columns only), positioning  
pins and cables:

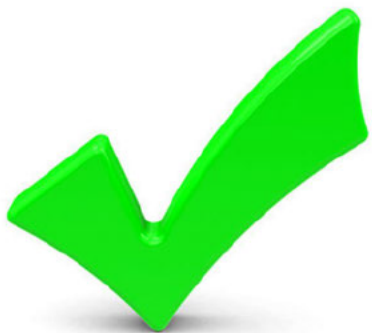
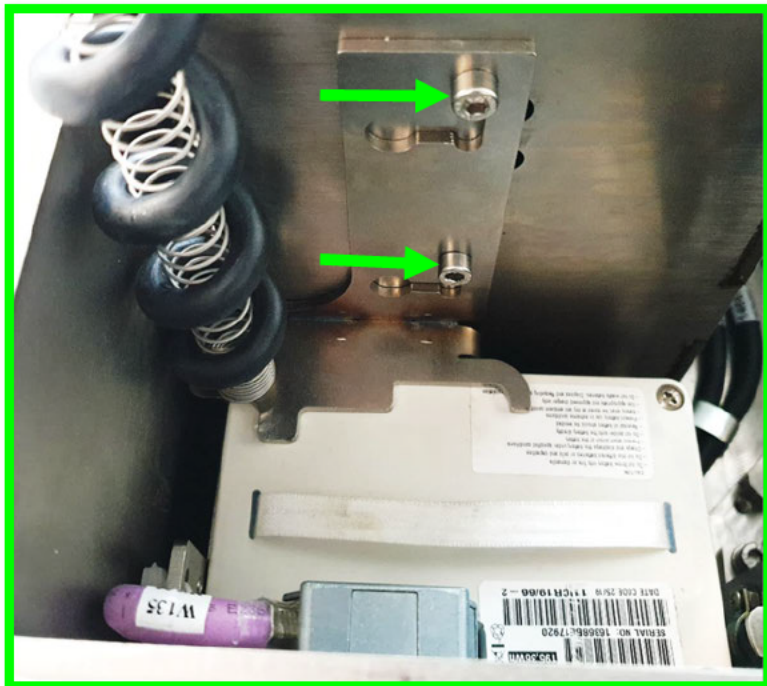
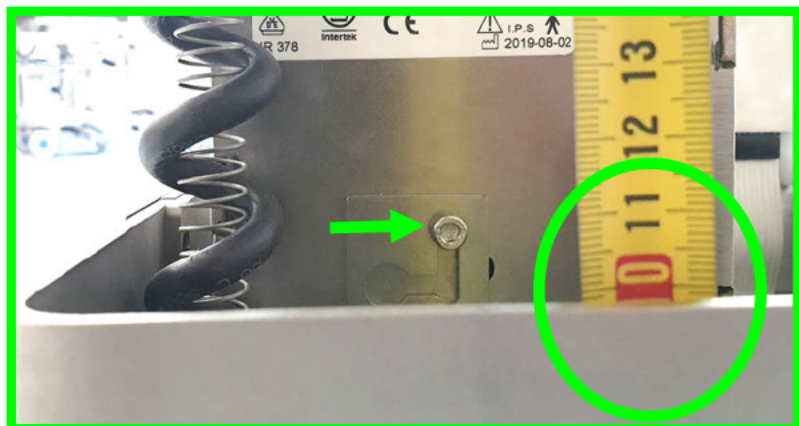
7. Battery correctly mounted in  
TS7500/TS5500 (motor side, only  
mobile column) cable holder is  
installed correct, no cable under  
the battery (flat on base), distance  
correct:

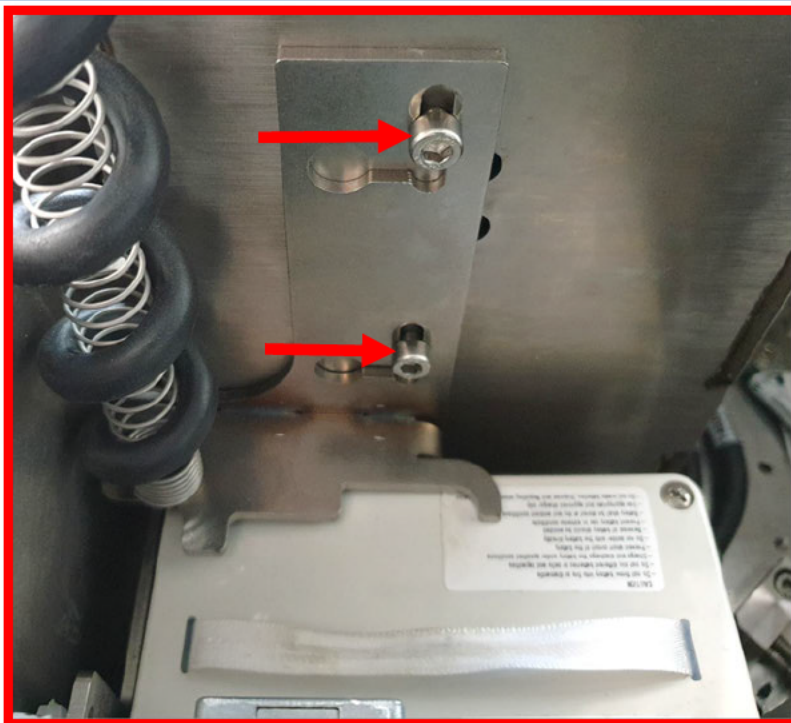
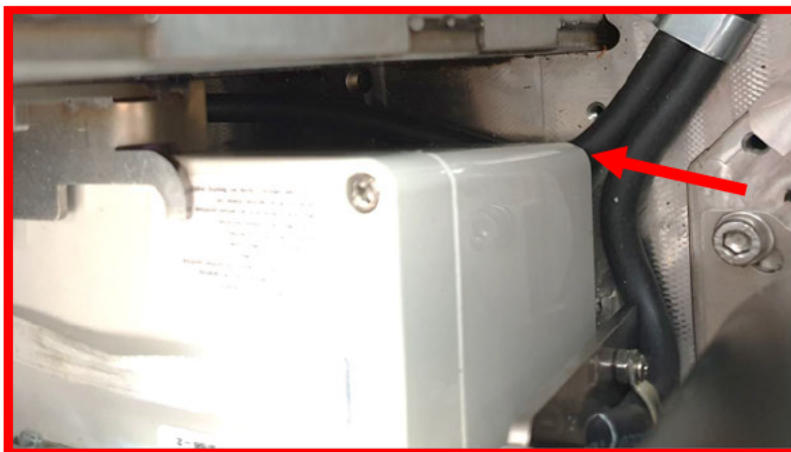
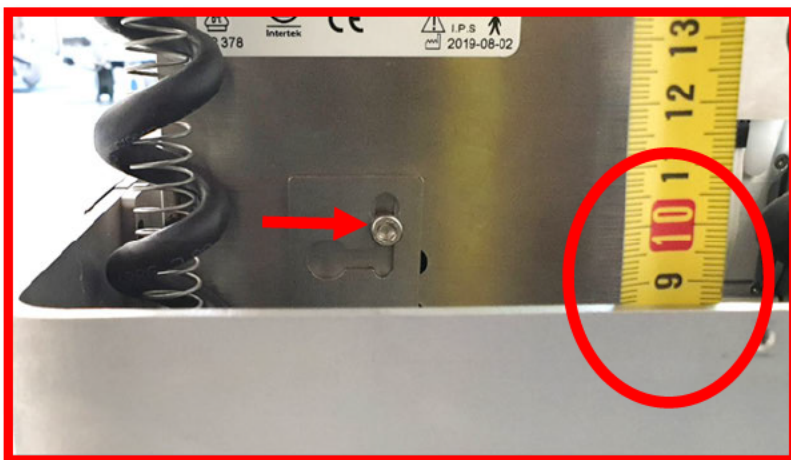
8. Battery incorrectly mounted in TS7500/TS5500 (motor side, only mobile column), cable holder is installed incorrect, cable under the battery, distance incorrect:

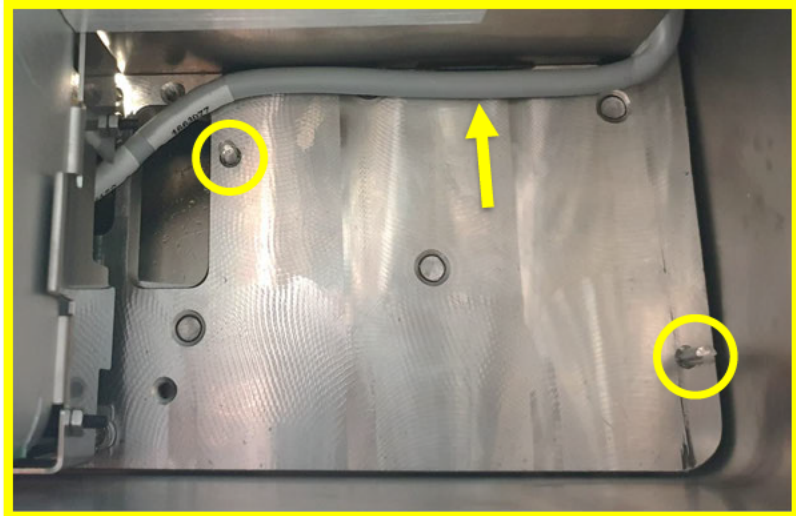
9. Installation situation  
TS7000(dV) (power supply side),  
positioning pins and cable on the  
guide side:

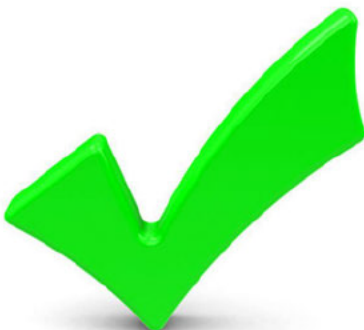
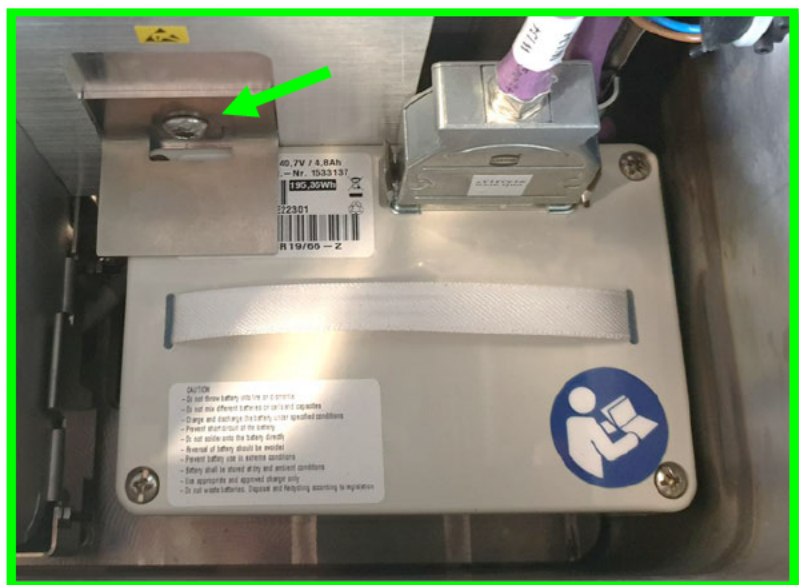
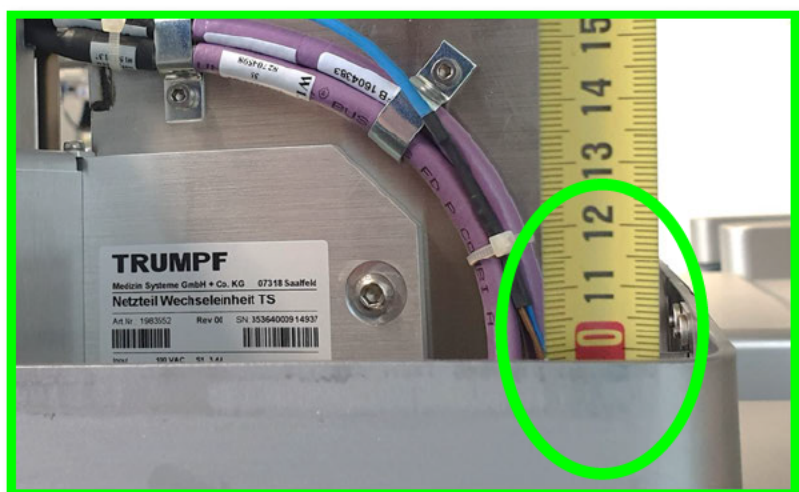
10. Battery correctly mounted in  
TS7000(dV) (power supply side),  
battery mounting bracket is  
installed correct, battery is flat on  
bottom of column, distance  
correct:

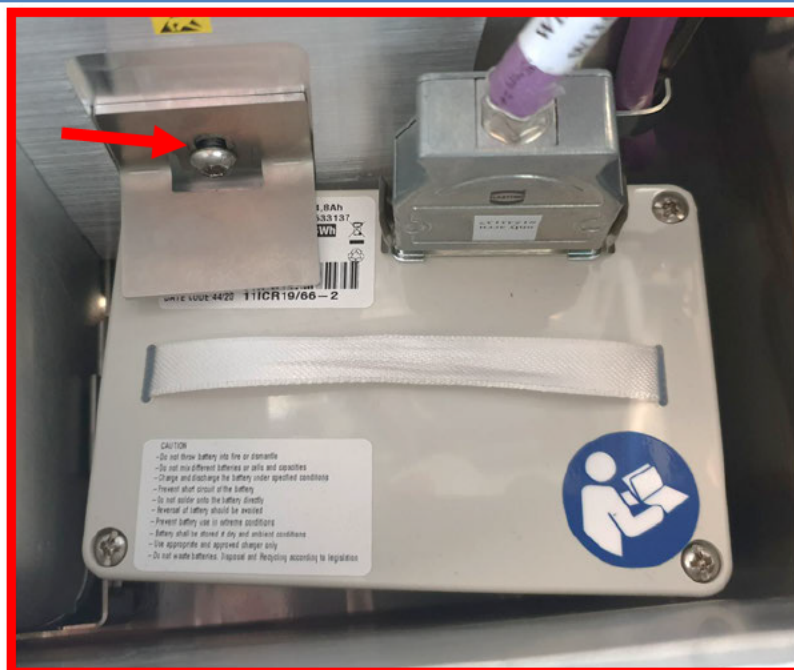
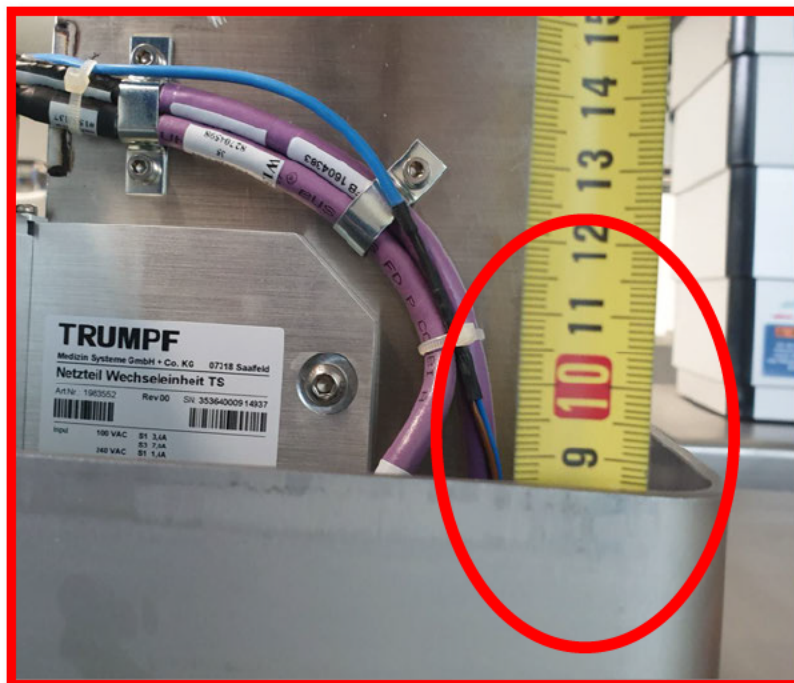
10. Battery incorrectly mounted in TS7000(dV) (power supply side), battery mounting bracket is installed incorrect, battery is not flat on bottom of column, distance incorrect:

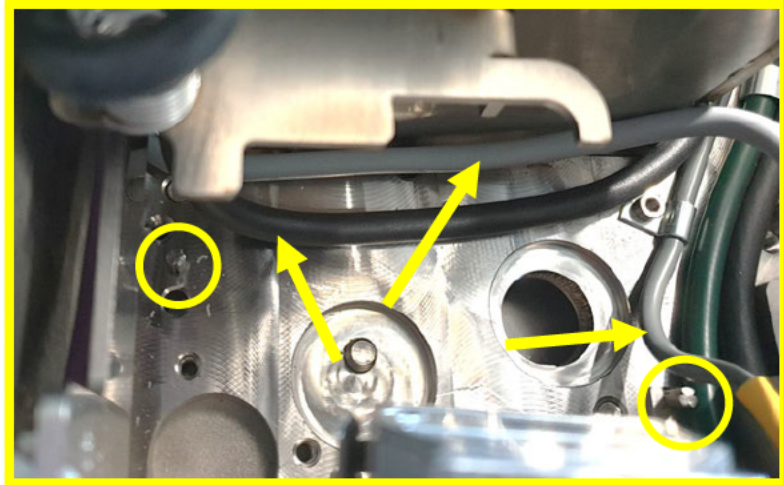
11. Installation situation  
TS7000(dV) (Motor side)  
positioning pins and cables:

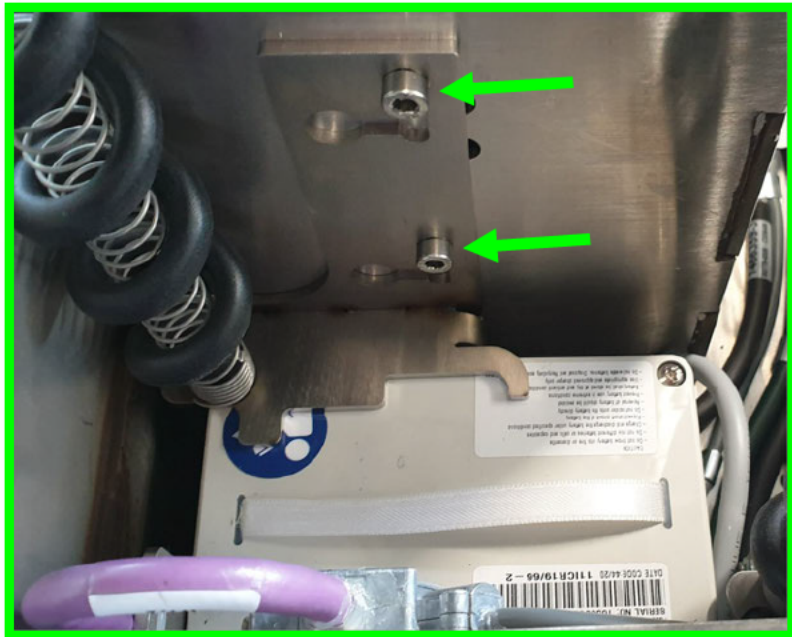
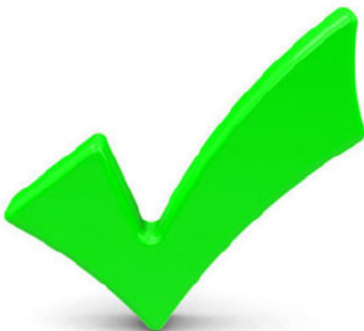
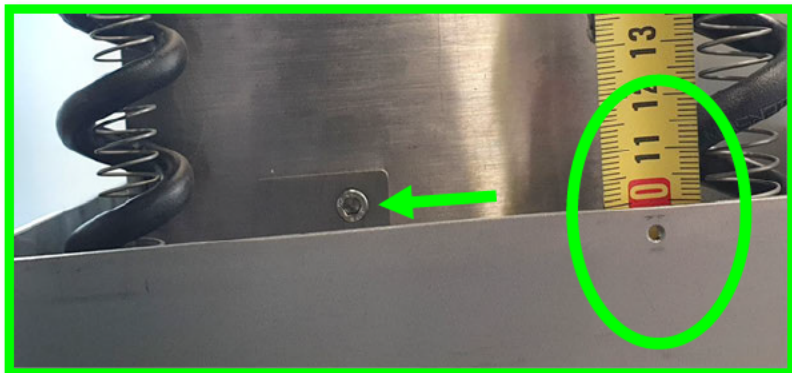
12. Battery correctly mounted in  
TS7000(dV) (motor side), cable  
holder is installed correct, no  
cable under the battery (flat on  
base), distance correct:

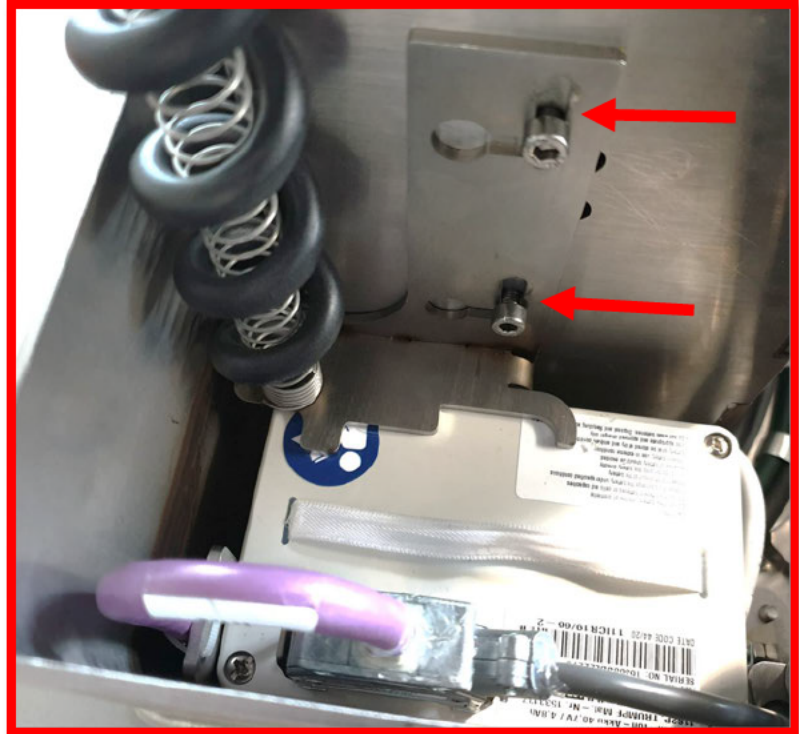
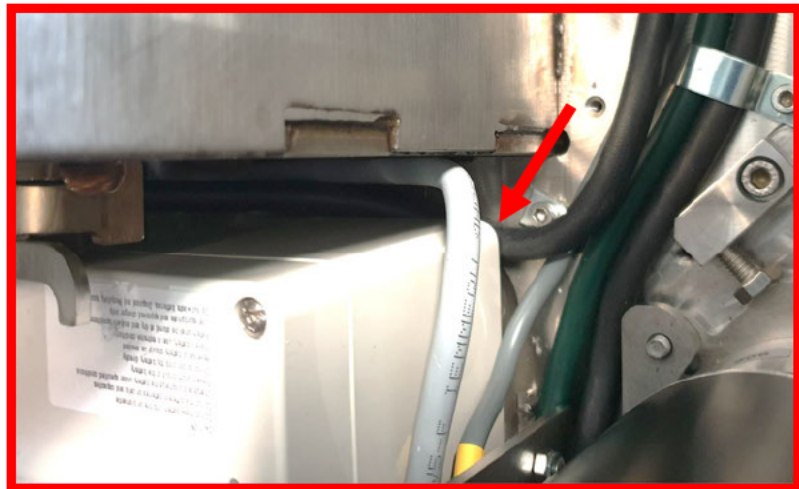
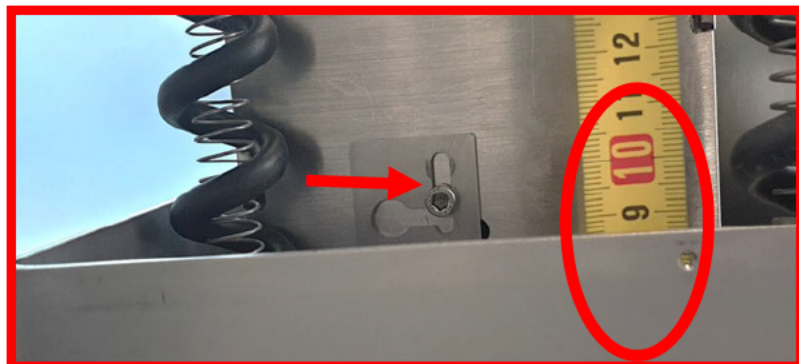
13. Battery incorrectly mounted in TS7000(dV) (motor side), cable holder is installed incorrect, cable under the battery, distance incorrect:
