URGENT Field Safety Notice

Philips Allura Xper R7.6- R8.1 systems

Delay of installation of the Lifetime Extension (LTE) kit in Allura Xper R7.6-R8.1 systems may lead to a broken propeller motor clamping bolt and a broken X-ray tube locking bolt.

Date: 11-NOV-2024

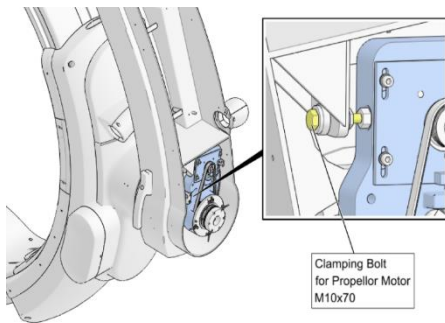
Figure 1: Clamping bolt of the C-arm propeller drive

Philips has identified potential safety issues with delayed LTE kit installations for Allura R7.6-R8.1 systems exceeding 10 years of life. The kit includes a propeller motor clamping bolt (see Figure 1) and the X-ray tube locking bolt (see Figure 2). If one of these bolts breaks, part of the system will not function as expected.

If the installation of the LTE kit is delayed, breakage of the propeller motor clamping bolt and/or the X-ray tube locking bolt may be expected. If this occurs,

- The broken propeller motor clamping bolt may cause erratic C-arm movements, and potentially colliding with patients or bystanders (see Figure 3). These unbalanced movements may also cause the system to falsely detect a collision, consequently blocking motorized C-arm movements.
- The broken X-ray tube locking bolt may cause the tube to hit the cover, causing unexpected noise and the appearance of a black area (maximum up to 25%) on the X-ray image. Consequently, the area of interest in the X-ray image may be obscured, leading to the need for an additional scan.

Philips will contact all affected customers to arrange for a Field Service Engineer visit to install a Lifetime Extension Kit (reference FCO72200598). As of the date of this Urgent Field Safety Notice, Philips expects the solution to be available by Q1 2025.

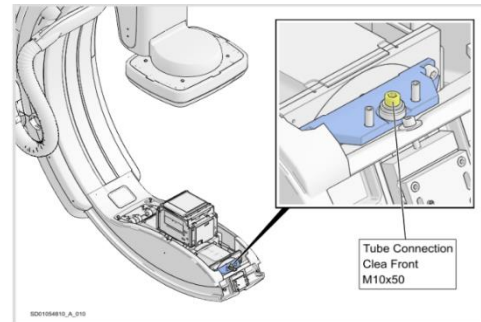
Figure 2: Locking bolt of the X-ray tube

A broken X-ray tube locking bolt could cause a black area to appear on the X-ray image, which may obscure the area of interest. This may require repeat imaging (up to 1 or 2 additional X-ray images or 3D scans), leading to additional radiation exposure. However, this additional radiation is not expected to exceed the thresholds for tissue reactions set by the International Commission on Radiological Protection (ICRP) for the risk of illness or injury.
