## Field Safety Notice

Reference: R546

This voluntary Field Safety Notice (FSN) is to inform you about a Field Safety Corrective Action (FSCA) for the AR-9800 Synergy RF Console.

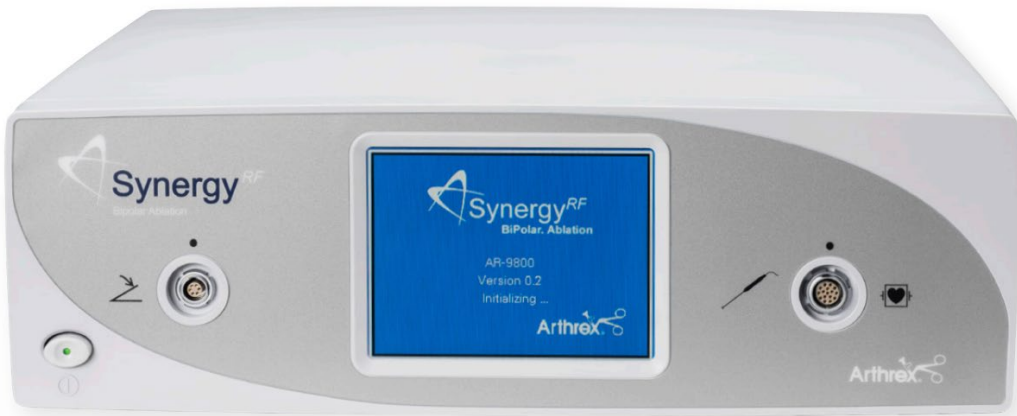
New label

Upon initial power up of the AR-9800 there is a potential, with some electrical services, that an inrush current may occur. If this inrush current is to occur, there is a possibility that the circuit breaker trips. If the breaker trips, resetting the circuit breaker will be required to restore power. Other devices connected to the same electrical circuit would experience a temporary power outage until the circuit breaker is reset or the devices are connected to another power circuit.

Arthrex has identified 77 occurrences of complaints reporting breakers tripping for devices at Rev. 6 or below. The reported events have never resulted in harm to patients, users or third parties. Although no harm has been reported, it was determined that if a failure occurs, the worst potential outcome would be a failure to complete a procedure.

To resolve this issue, an Arthrex employee will replace the current T8A fuses with new F4A fuses and relabel the device with new fuse specifications.

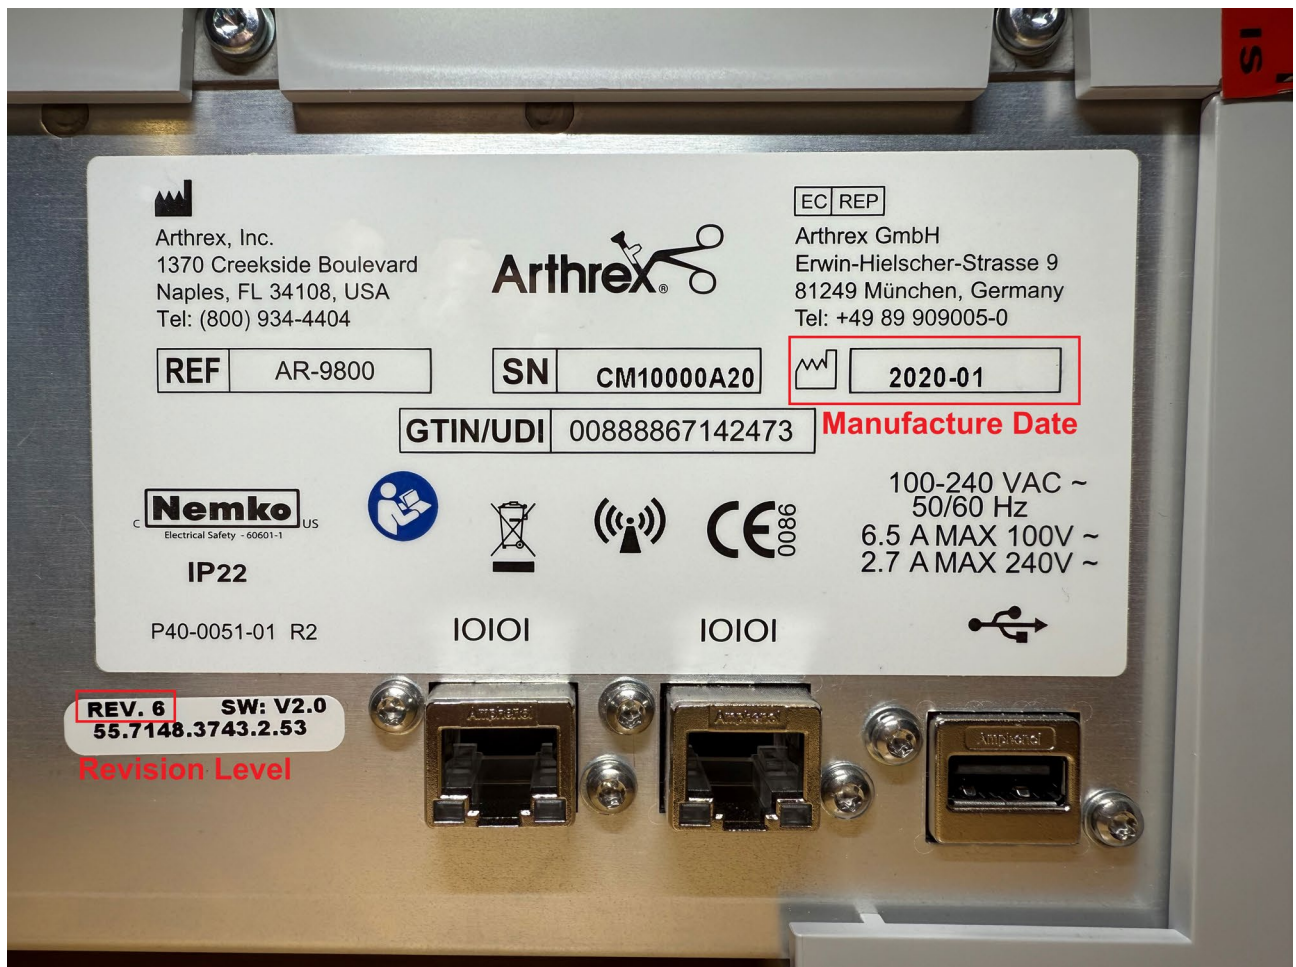
1. Immediately identify the indicated AR-9800 you have in your control.  
The affected devices can be identified via a label on the back of the device that indicates the revision level (see picture below). If the revision level label is not present, the device should be considered affected if the manufacturing date is prior to July 2020. The manufacturing date is indicated on the main label on the back of the device.

2. The affected devices must only be used on a dedicated electrical circuit until an Arthrex employee has performed the necessary field correction.
3. Please fill out the “Arthrex customer’s response form” located on the last page of this document and return it to [vigilance@arthrex.de](mailto:vigilance@arthrex.de).
4. After receiving your response form, Arthrex will reach out to you to schedule an appointment to correct the affected devices.
