<Reference: 97125289F-FA>

September 2025

Urgent Field Safety Notice

Subject: Field Safety Notice – Update to December 2024 Field Safety Notice: Software designed to prevent initiation of Safety Mode in an ambulatory setting due to a high battery impedance state in ACCOLADE™ Pacemakers and CRT-Ps (Boston Scientific Reference: 97125289F-FA).

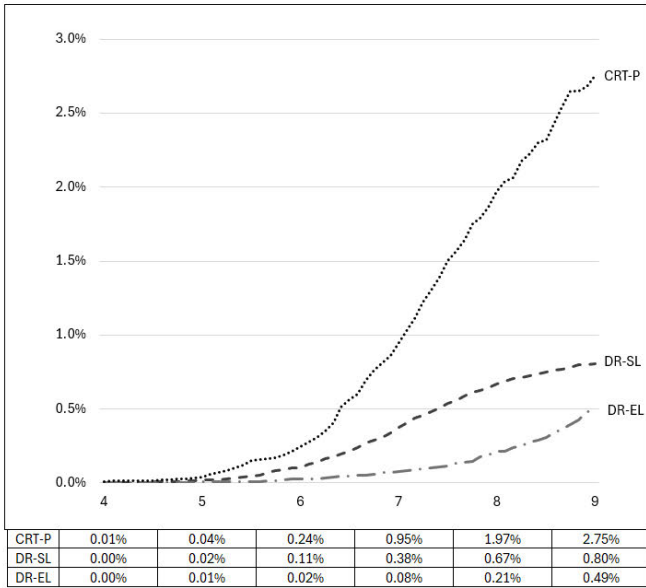
Figure 1 Occurrence rates for high battery impedance induced Safety Mode in the December 2024 advisory population

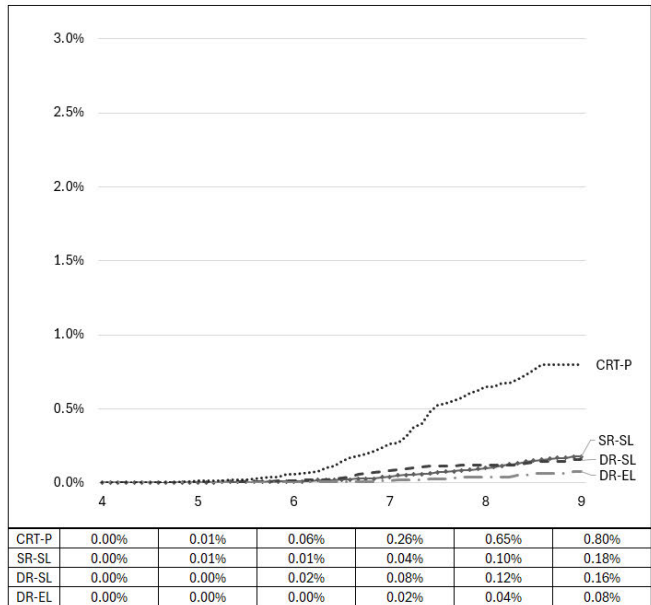
Figure 2 Occurrence rates for high battery impedance induced Safety Mode in remaining devices
