For all users of mint Lesion™ versions 3.9.0, 3.9.1, 3.9.2, 3.9.3, 3.9.4, 3.9.5, 3.10.0 and 3.10.1

2024-11-13

**Urgent Field Safety Notice**

**For the Attention of: All users of mint Lesion™ versions from 3.9.0 up to 3.10.1**

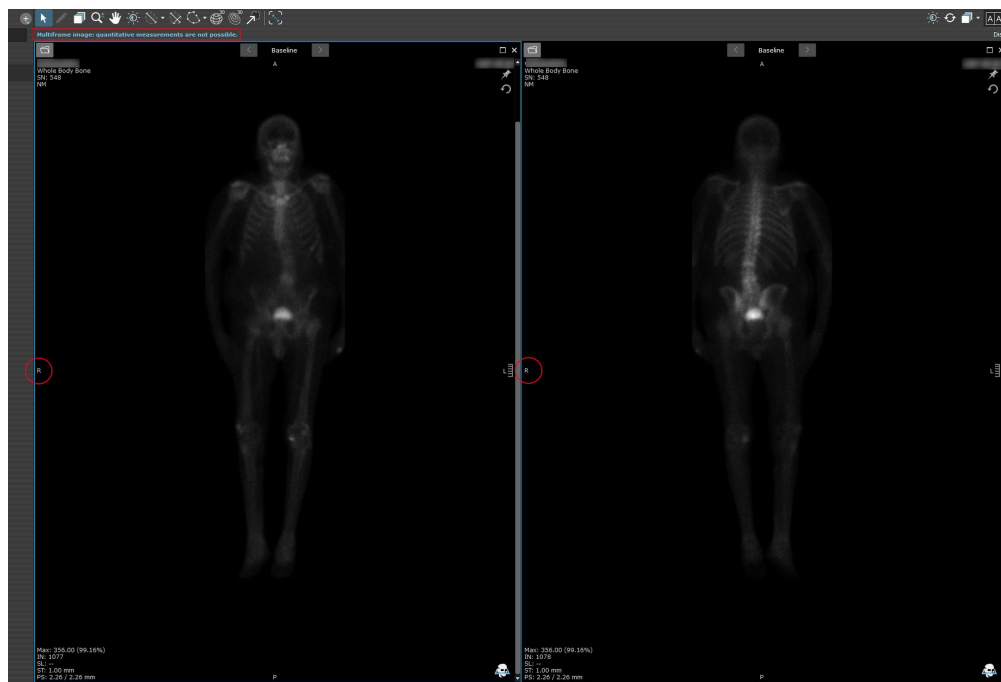
mint Lesion™ shows patient orientation markers (L,R,A,P,H,F) for each image in a DICOM series. They describe how the patient is positioned in the image. When the malfunction occurs, these orientation markers may be wrong. For example, the left (L) and right (R) markers may be transposed (see Figures 1 and 2). If not noticed, this could lead to a user assuming a wrong anatomical location of a finding.

**Figure 1: Whole-body bone-scan images with two projections. The left/right (L/R) orientation markers in the left anterior projection are correct while the L/R orientation markers in the right posterior projection are transposed.**

Verify the patient orientation based on anatomical landmarks that you can see in the images, when you rely on patient orientation for reporting findings (e.g., "anomaly in left kidney").

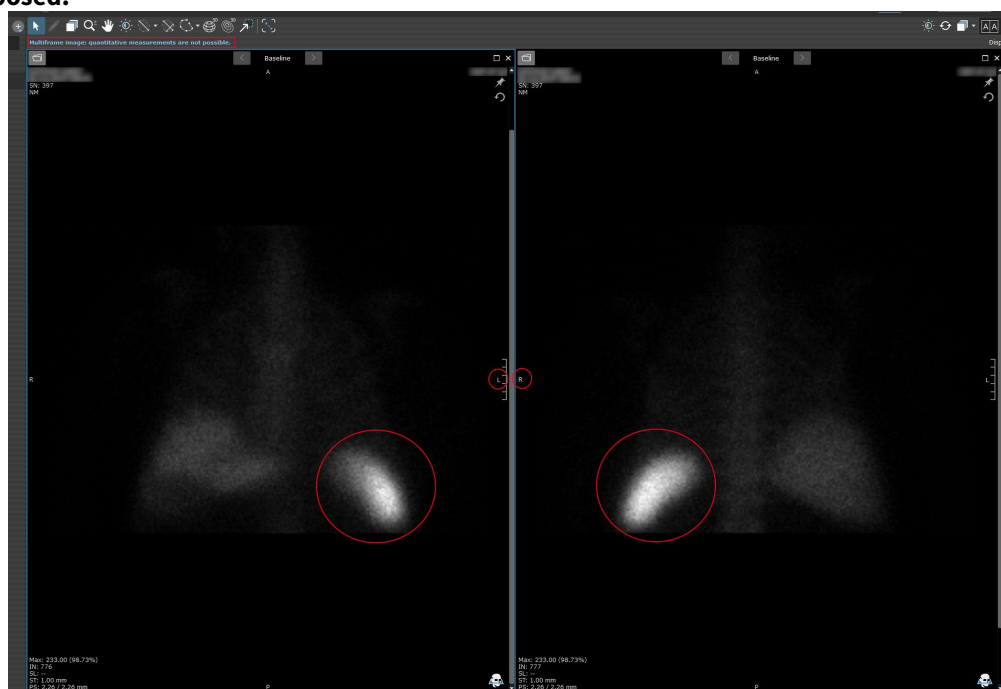
**Figure 2: Chest bone-scan images with two projections. The L/R orientation markers in the left projection are correct while the ones in the right projection are transposed.**
