## **FIELD SAFETY NOTICE**

### **Recommendation to implement Exelia software version 1.2.3 and previous malfunctions in the Exelia system**

**Subject:** Field Safety Notice regarding new Exelia software version 1.2.3

**Affected Products:** Exelia SP; Exelia VP; Exelia Combox; Exelia Therapy Manager

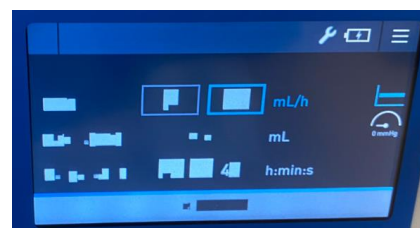
The software may suddenly display two different screens alternately (e.g., syringe installation screen and home screen) or prevent a value from being set.

It could also happen that the values suddenly become unreadable, or appear frozen for several seconds or even minutes. The infusion continues normally.

Inability to program the infusion. If an infusion is in progress, it is necessary to transfer the infusion to another device and then turn off the device. In the worst-case scenario, a technical error 16.18.39 could occur with a potential infusion stop.

If the event occurs, transfer the infusion to another device, then press the ON/OFF button until the module turns off, i.e. for 3 seconds or for 20 seconds if the switch-off is not effective in 3 seconds. Then turn the module back on and it can continue to be used if no fault is reported when it is re-ignited.

Upgrade all your Exelia devices to the latest software version "Exelia 1.2.3".
