## Updated Field Safety Notice

### Philips MR Systems

Gradient Coil component failures may act as a heat source with potential to produce smoke and/or fire.

May 2026

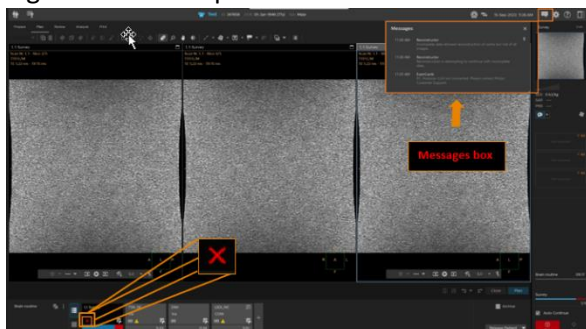
Figure 5. UI example SW Version R11.

- 4.3. When scan aborts occur the symbol is shown and applicable messages are presented in the message box (see Figure 5 and Figure 6 examples)
  - 4.3.1. Check the status of the error messages in the User Interface (UI) screen. Click to expand the message box in case previous messages are hidden, see orange box in Figure 5 and Figure 6 below. If possible, correct the issue that is relevant to the error shown and continue scanning, for example:
    - "RF door must be closed while performing scan. Scan aborted."
    - "Patient support is moved while scanning, scan stopped."
    - "Coil A (or B) failure, coil disconnected?"

- 4.3.2. If, after a scan abort, one of the following conditions occur five times in a row stop scanning immediately and contact Philips Service to describe the problem:
  - If there is no error message in the message box
  - If the error message meaning is not clear
- 4.3.3. If the error message "Gradient amplifier Rack Fault" is received two times in a row, or if the error message "Gradient amplifier Rack Fault" is preceded or followed by an aborted scan with no message, then stop scanning immediately and contact Philips Service to describe the problem.

- 4.3.4. If you encounter any of these conditions described in 4.3.2 or 4.3.3 do not attempt any additional/further scans, including without limitation do not attempt any phantom scanning until your system has been checked and released by a Philips Service representative.

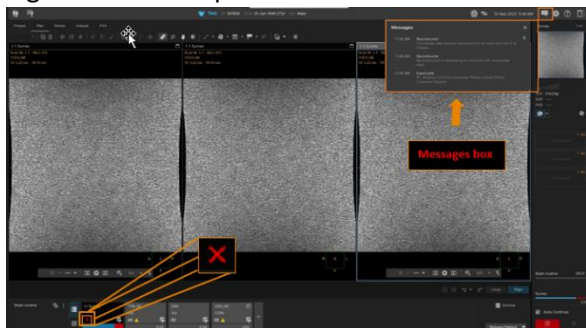
Figure 5. UI example SW Version R11.

- 4.3. When scan aborts occur the symbol is shown and applicable messages are presented in the message box (see Figure 5 and Figure 6 examples)
  - 4.3.1 Check the status of the error messages in the User Interface (UI) screen. Click to expand the message box in case previous messages are hidden, see orange box in Figure 5 and Figure 6 below. If possible, correct the issue that is relevant to the error shown and continue scanning, for example:
    - “RF door must be closed while performing scan. Scan aborted.”
    - “Patient support is moved while scanning, scan stopped.”
    - “Coil A (or B) failure, coil disconnected?”.

- 4.3.2 If, after a scan abort, one of the following conditions occur five times in a row stop scanning immediately and contact Philips Service to describe the problem:
  - If there is no error message in the message box
  - If the error message meaning is not clear
- 4.3.3 If the error message “Gradient amplifier Rack Fault” is received two times in a row, or if the error message “Gradient amplifier Rack Fault” is preceded or followed by an aborted scan with no message, then stop scanning immediately and contact Philips Service to describe the problem.
- 4.3.4 If you encounter any of these conditions described in 4.3.2 or 4.3.3 do not attempt any additional/further scans, including without limitation do not attempt any phantom scanning until your system has been checked and released by a Philips Service representative.
