## URGENT Field Safety Notice

### EPIQ Elite v14.0 Software Issue with C5-1 Transducer

AUG-2026

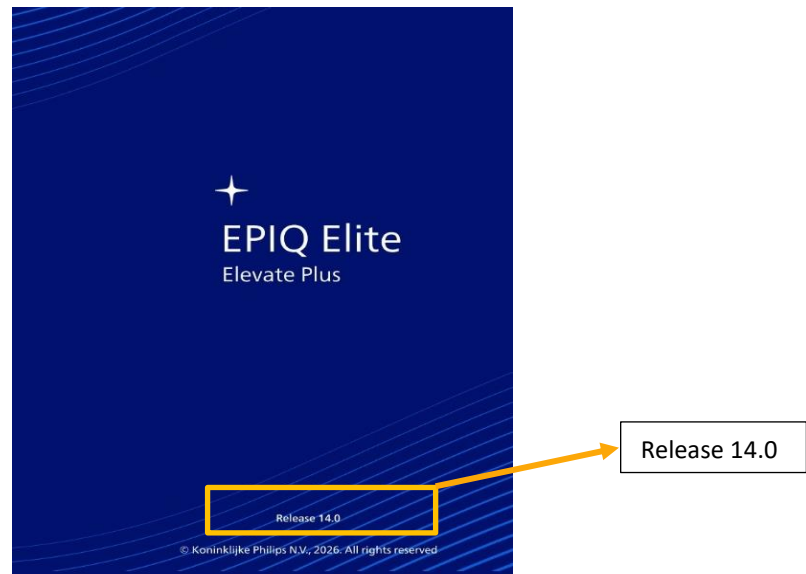
- A. To determine if your EPIQ system is operating with version 14.0, utilize one of the following two methods:
  1. The software version will be displayed on the splash screen during the system boot up as shown in Figure 3.

*Figure 3 Software Version*
