# URGENT - FIELD SAFETY NOTICE Telemis-Medical Software Reference FSN 28146

Date: 24th January 2023

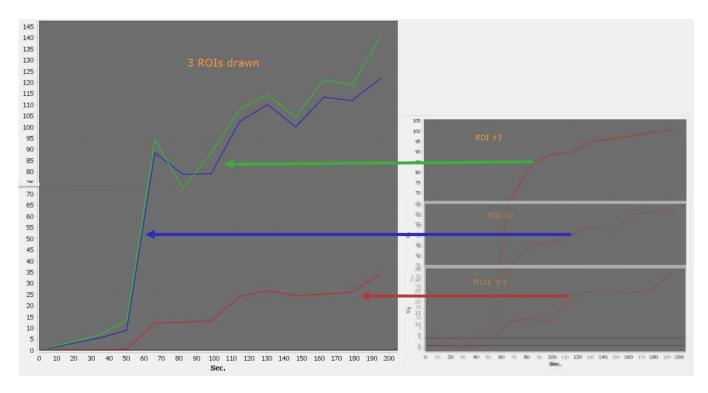
### **Security recommendations**
