Update of Urgent Field Safety Notice

Update of the communication issued in August 2022 related to the risk of Minute Ventilation artefact oversensing in patients with a subset of abnormal high polarization XFine passive pacing leads, when connected to ALIZEA / BOREA pacemakers.

FSCA identifier: CRM-SAL-2022-001 – Rev. B

Affected devices: Subset of MicroPort CRM XFine leads (models XFine TX25D, XFine TX26D, XFine JX24D; XFine JX25D) connected to MicroPort CRM ALIZEA or BOREA pacemakers (models ALIZEA DR 1600, ALIZEA SR model 1300, BOREA DR model 1500, BOREA SR model 1200).

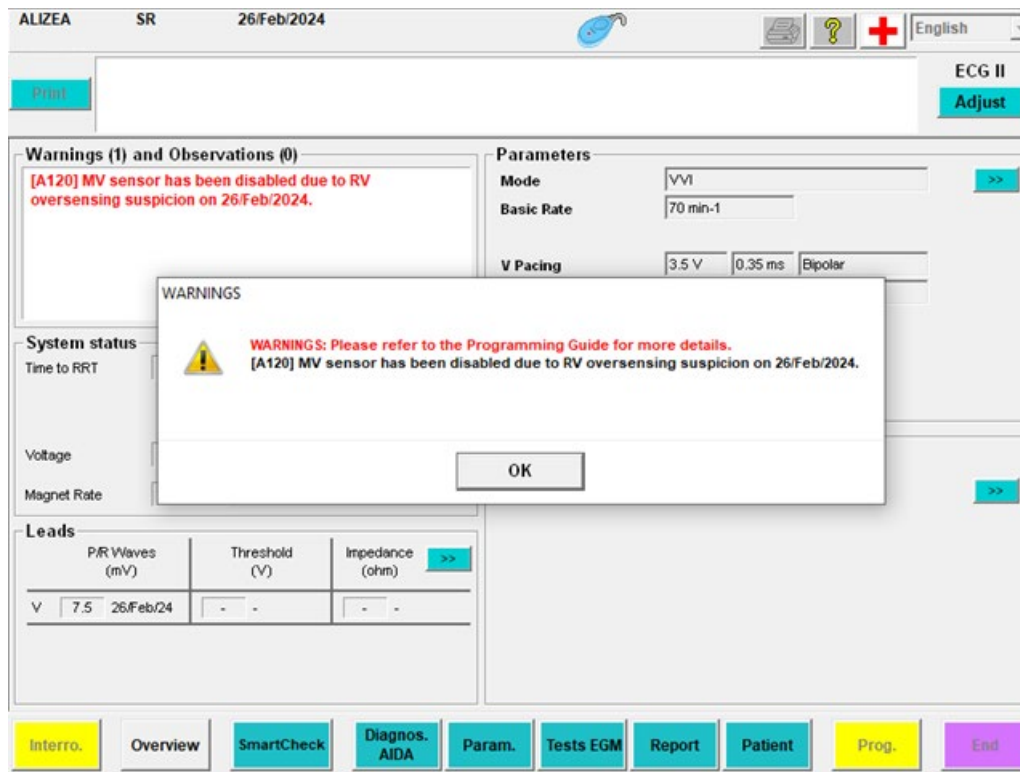
At interrogation, when MV oversensing occurred in the ventricle, a pop-up is displayed:

- [A120] MV sensor has been disabled due to RV oversensing suspicion on [date]

Figure 1: Warning for the deactivation of the MV sensor due to MV oversensing

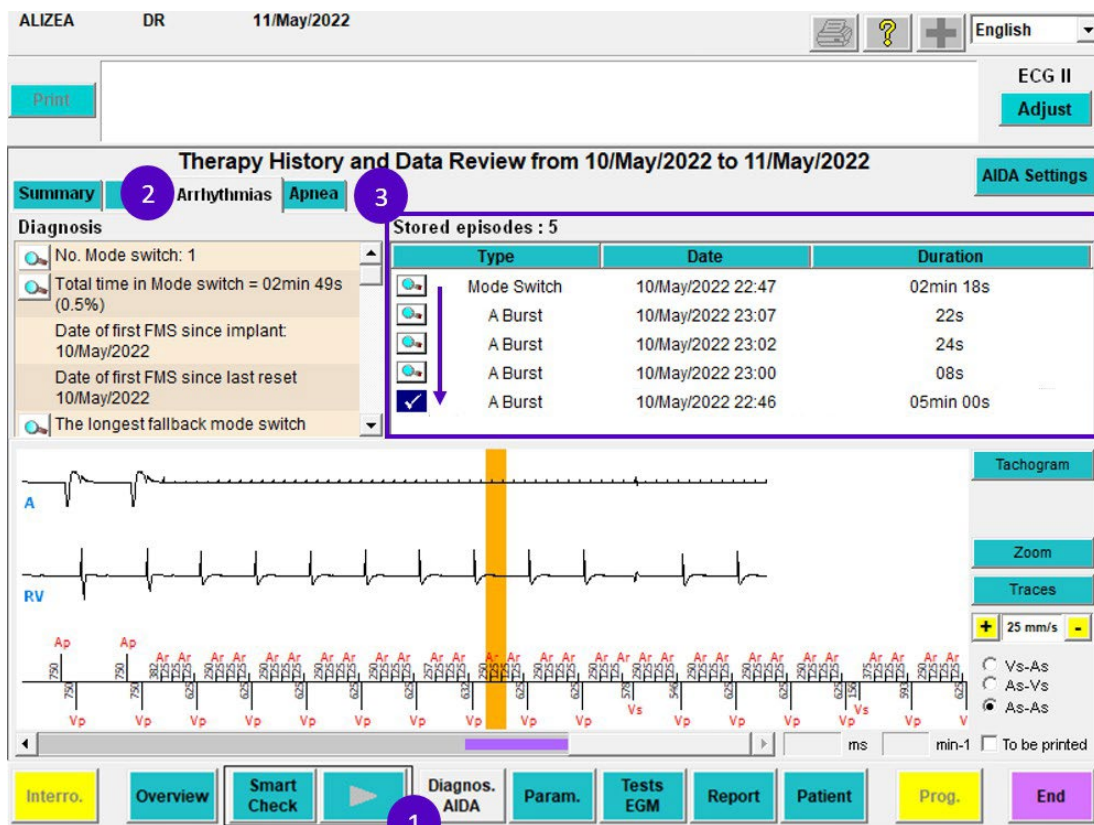
Figure 2: Sequence for checking the presence of MV oversensing in recorded episodes

1. Select the “Diagnos. AIDA” tab in the menu bar at the bottom of the screen;
2. Select the “Arrhythmias” tab;
3. Check recorded episodes individually to identify the presence of MV oversensing.

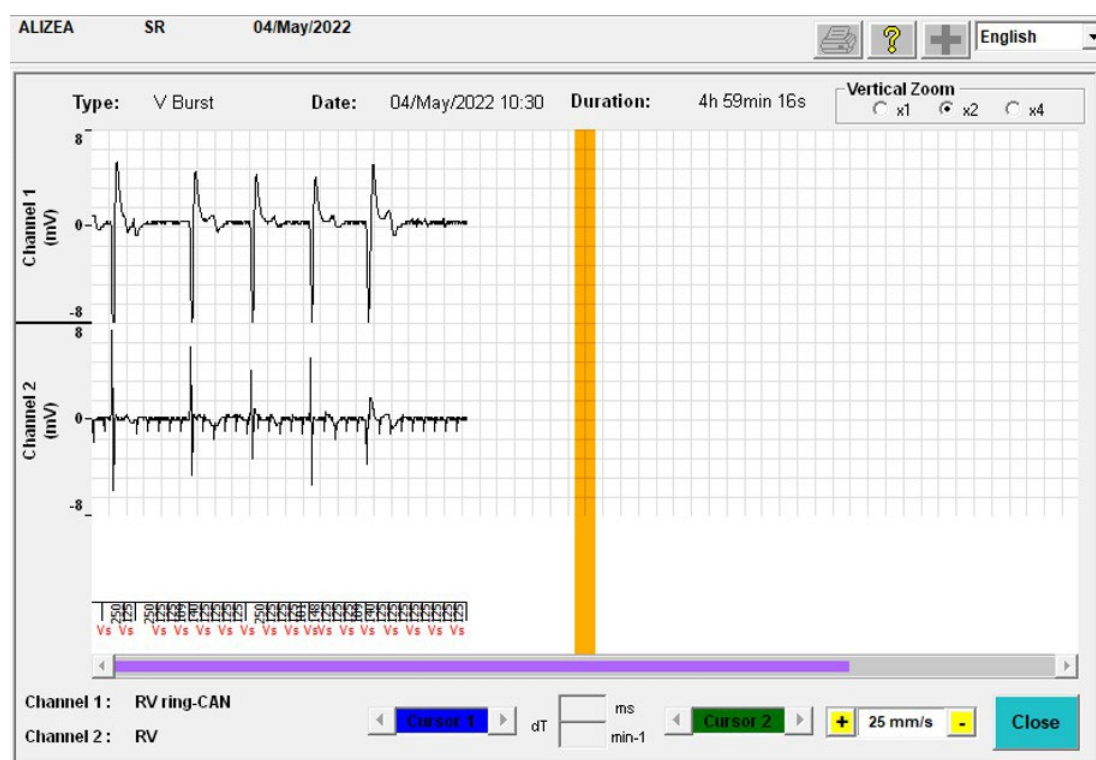
MV noise oversensing is characterized by the presence of repetitive 125ms or 250ms cycles (as illustrated below), visible in:

Figure 3: Illustration of “V Burst” episode due to MV noise oversensing on an SR pacemaker

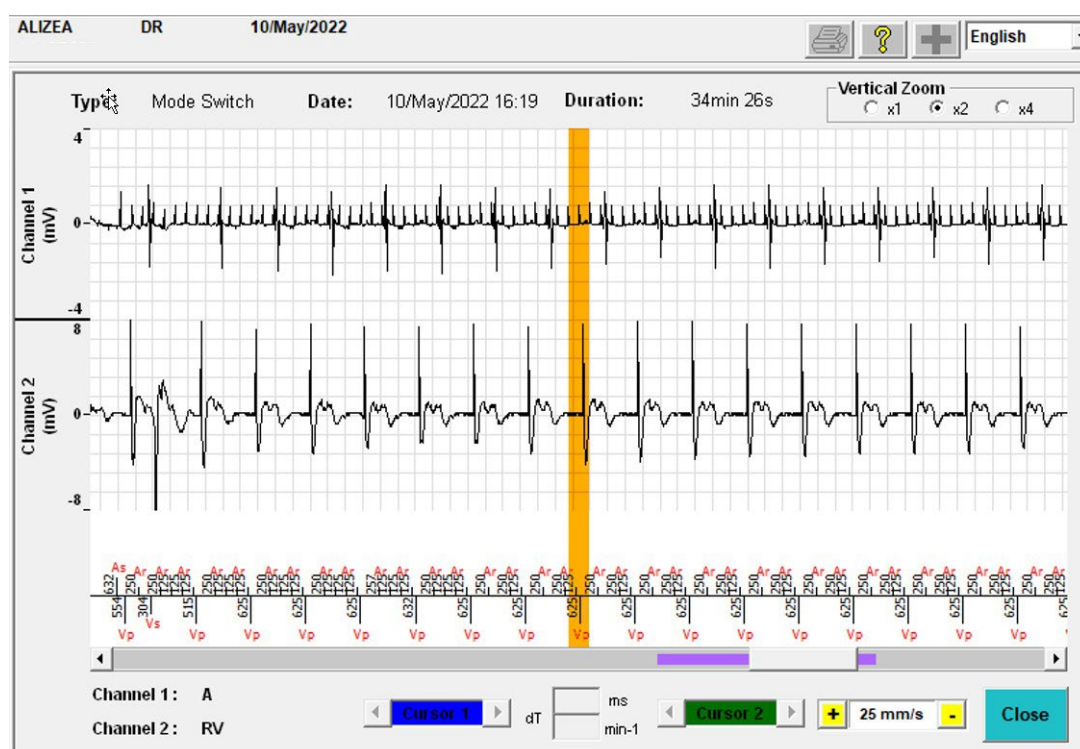
Figure 4: Illustration of “Mode Switch” episode due to MV noise oversensing on a DR pacemaker
