Urgent Field Safety Notice

Medtronic Model 37751 Recharger included in Model 37651 Charging System

Important Device Information related to Deep Brain Stimulation

Medtronic reference: FA735

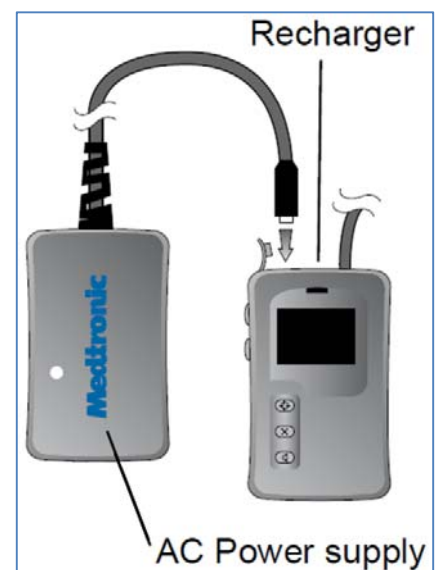
1. In order to prevent this unresponsive error state, the Recharger should be plugged into the AC power supply (by aligning white triangles) prior to begin a recharging session of the neurostimulator and the Recharger should remain connected to the AC power supply until the recharging session is complete (see Figure 1). Note: The AC power supply does not need to be plugged into a power outlet if the Recharger is charged.
2. If the Recharger is not connected to the AC power supply during a recharging session of the neurostimulator, the unresponsive error state may occur. In this situation, Medtronic requests that you assist patients with a reset of their Recharger by following the reset instructions enclosed. Note: This issue can recur after reset if the recharging instructions are not followed.

- To ensure this issue does not occur, Medtronic recommends all affected patients follow the recharge practice explained above. Keeping the Recharger plugged into the AC power supply during recharging will prevent this error state from occurring.
- If you are contacted by a patient with a Recharger in an unresponsive error state, you can assist the patient with a reset of their Recharger by following the reset instructions enclosed.
- Medtronic is working on a permanent solution for this issue. Until a permanent solution is in place, Medtronic recommends you discuss this issue and the issue mitigation with any new patient implanted with a rechargeable neurostimulator and provide them with a copy of the patient notification.

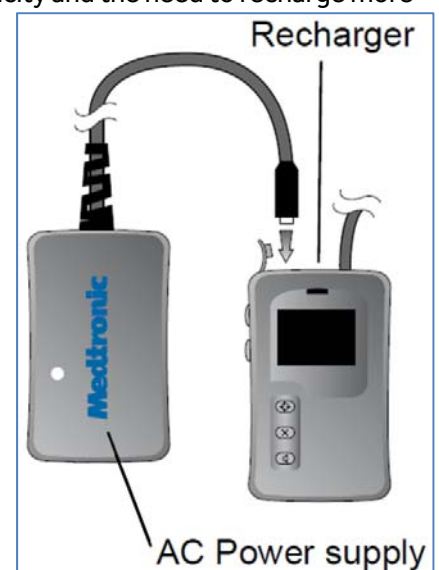
Figure 1

1. In order to prevent this unresponsive error state, the Recharger should be plugged into the AC power supply (by aligning white triangles) prior to begin a recharging session of the neurostimulator and the Recharger should remain connected to the AC power supply until the recharging session is complete (see Figure 1). Note: The AC power supply does not need to be plugged into a power outlet if the Recharger is charged.
2. If the Recharger is not connected to the AC power supply during a recharging session of the neurostimulator, the unresponsive error state may occur. In this situation, Medtronic requests that you assist patients with a reset of their Recharger by following the reset instructions enclosed. Note: This issue can recur after reset if the recharging instructions are not followed.

- To ensure this issue does not occur, Medtronic recommends all affected patients follow the recharge practice explained above. Keeping the Recharger plugged into the AC power supply during recharging will prevent this error state from occurring.
- If you are contacted by a patient with a Recharger in an unresponsive error state, you can assist the patient with a reset of their Recharger by following the reset instructions enclosed.
- Medtronic is working on a permanent solution for this issue. Until this solution is in place, as appropriate please discuss this notification and the issue mitigation with your current and new patients implanted with a rechargeable neurostimulator to ensure they understand the mitigations to prevent this issue and the steps required to resolve the issue if it occurs. The enclosed patient notification can be used to facilitate this conversation as needed.

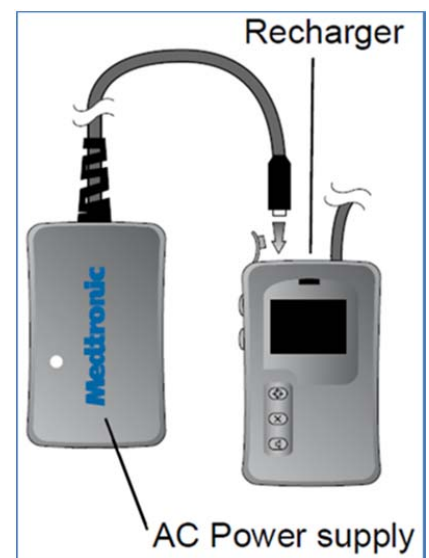
Figure 1

1. Plug the AC power supply into your Recharger, lining up the white triangles, prior to begin a recharging session of the implant (see Figure 1).
Note: The AC power supply does not need to be plugged into a power outlet, if the Recharger is charged.
2. Keep the AC power supply connected to the Recharger until the recharging session is complete.
Note: Make sure that you handle the Recharger, antenna, and AC power supply with care, and stabilize and secure the connections.

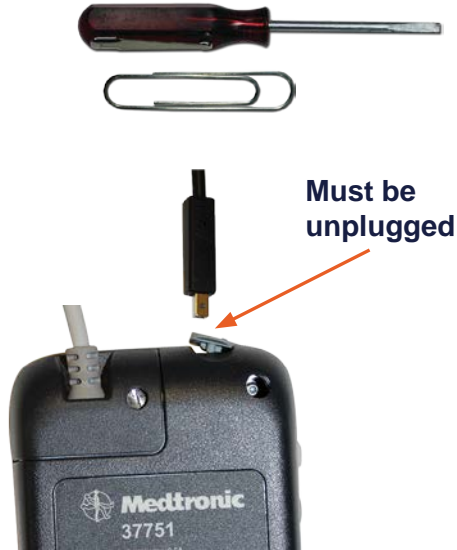
1 WHAT YOU NEED

- small Flathead screwdriver
- standard paper clip

WARNING: Recharger must be unplugged. Do not reset the recharger while it is plugged into the AC power supply.

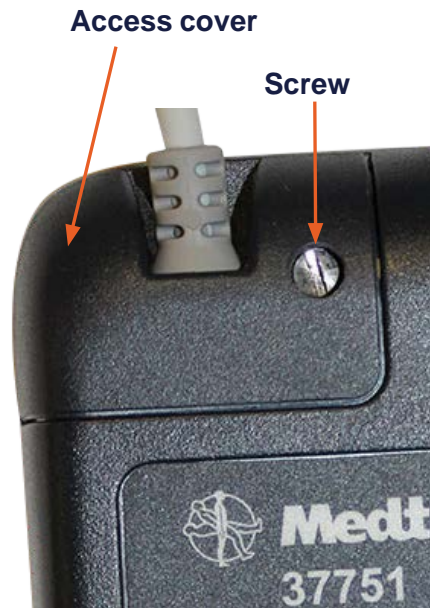
2 REMOVE ACCESS COVER

Use small Flathead screwdriver to unscrew and remove access cover.

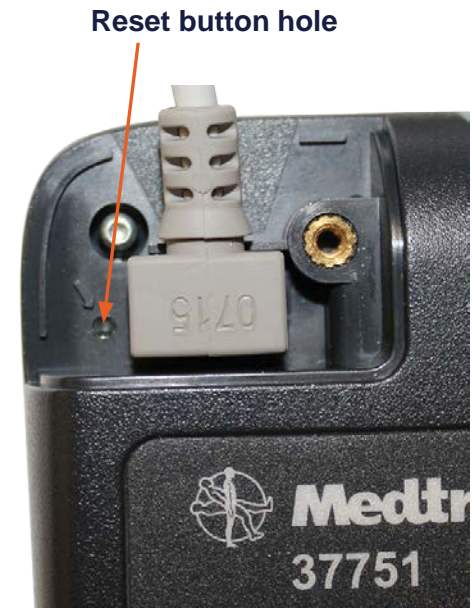
3 LOCATE RESET HOLE

Locate reset button hole.

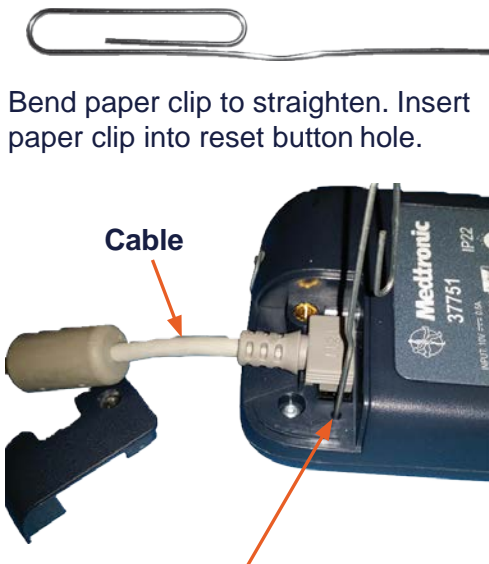
4 PERFORM RESET

Bend paper clip to straighten. Insert paper clip into reset button hole.

Press and hold reset button for 2 seconds. Replace access cover and tighten the screw.

Note: Ensure that the cable is still securely plugged in before you replace the access cover.

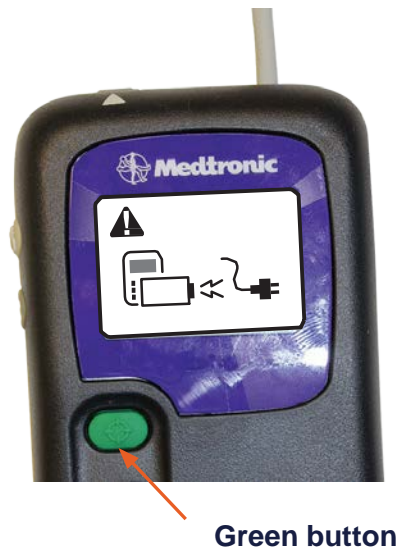
5 CLEAR SCREEN

The recharger displays the AC Recharge screen. Press the green button to clear the screen.

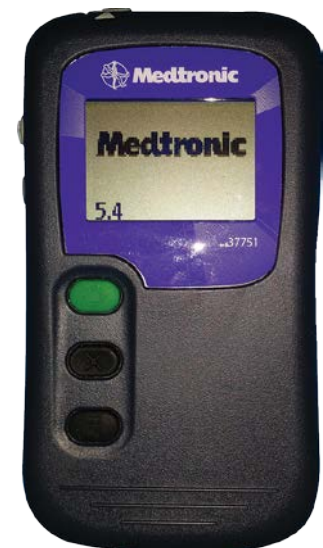
6 CONFIRM RESET COMPLETE

Press the green button again to start a charging session. If the recharger does not function, contact your Medtronic Representative.
