Urgent: Field Safety Notice
Update to October 2016 Field Action:
Important information regarding the Medtronic Model 37751 Recharger
(Included in Kit Models 37754, 97754, and 37651)

February 2019

Medtronic reference: FA735 Phase II

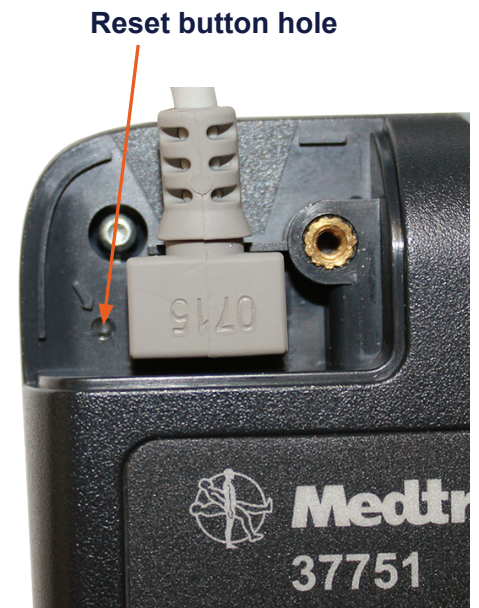
3 LOCATE RESET HOLE

Locate reset button hole.

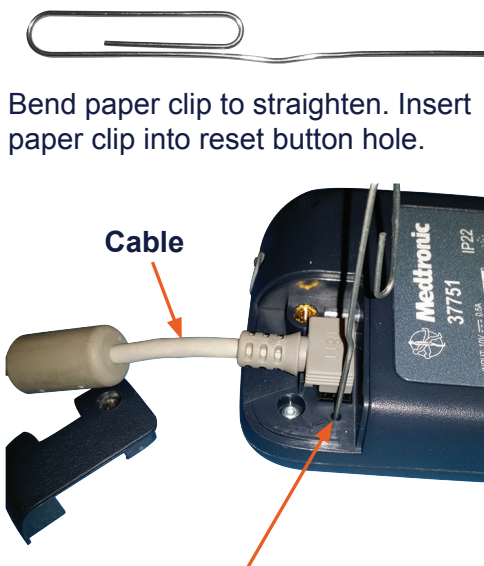
4 PERFORM RESET

Press and hold reset button for 2 seconds. Replace access cover and tighten the screw.

Note: Ensure that the cable is still securely plugged in before you replace the access cover.

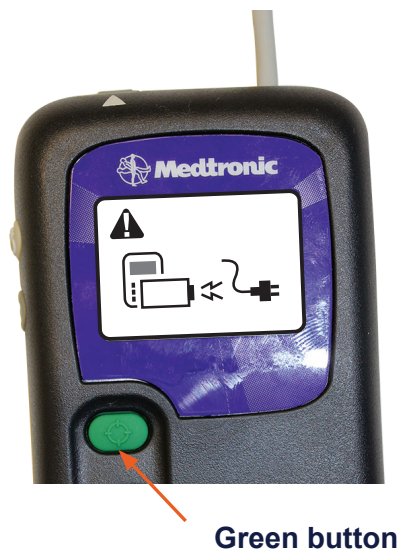
5 CLEAR SCREEN

The recharger displays the AC Recharge screen. Press the green button to clear the screen.
