## Urgent Safety Notice

Precautionary replacement of motors on older treatment tables

**Re:** ARCUS treatment tables from FREI AG

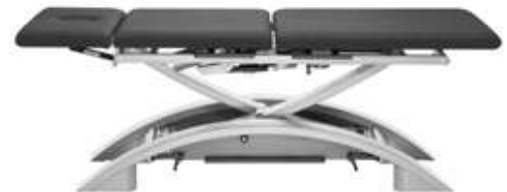
ARCUS treatment tables with article numbers:

Standard: 8.5100.00 ; 8.5100.50 ; 8.5100.50a  
Universal: 8.5105.00 ; 8.5105.50 ; 8.5105.50a  
Manual: 8.5110.00 ; 8.5110.50 ; 8.5110.50a  
Vojta 120cm wide: 8.5115.00 ; 8.5115.50 ; 8.5115.50a  
Vojta 100cm wide: 8.5116.00 ; 8.5116.50 ; 8.5116.50a

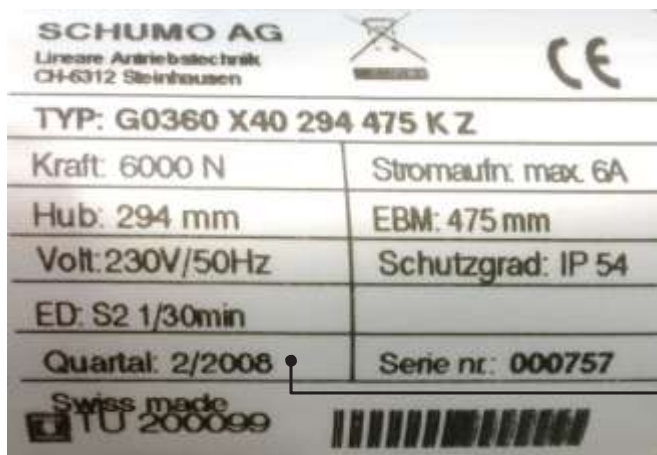
Example of a motor type plate:

Check the year of manufacture of all adjustment motors on your treatment tables. Motors older than 10 years should be replaced as a precaution. The age of the motor is indicated on the type plate of the motor or on the treatment table.

Year of  
manufac-  
ture

If this inspection fails or cannot be carried out, please stop using these treatment tables and contact FREI AG. We are happy to assist you with any questions regarding this measure. The age of the motors and thereby the replacement interval must be checked in the course of the recurring safety inspection.
