Aptio® Automation StreamLAB® Automation

Some modules missing pacemaker warning labels

Modules missing pacemaker warning labels

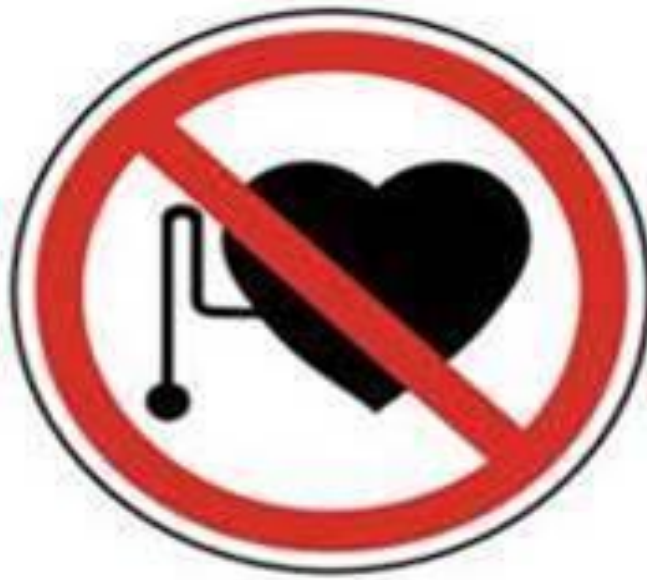
- In the modules listed in Table 1 and 2, the transport mechanism that moves the robot along the axes, generates a magnetic field which may interfere with pacemaker functionality at close distances.
- The pacemaker safety label shown below indicates the potential risk of interference to pacemaker functionality. On some modules, this label may be missing.

Tape this sheet to any module listed in Table 1 or Table 2 that is missing a warning label:

1. Personnel fitted with a pacemaker must not be at distances less than 200 mm (7.87 inches) of the modules axes (transport mechanisms) for the modules listed in Table 1 and Table 2 even if the warning label is missing.
2. Verify that the modules listed in Table 1 and 2 all have a pacemaker safety label attached either on the cover or inside the cover of the module. If there is no safety label on the module,

please remove the last page of this letter and tape a copy of the safety label to the cover of the module until an official Siemens product label is available.
