FIELD SAFETY NOTICE

PREVENTIVE CORRECTIVE ACTION CONCERNING SCHAERER SHOULDER ARTHROSCOPY PLATE, REF. NO. 90568 (25mm side rails) and 90569 (30mm side rails)

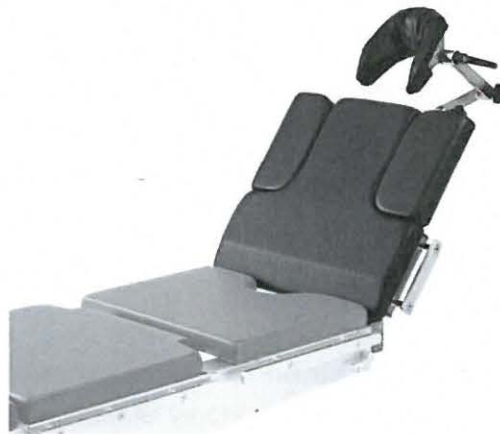
With this letter, we inform you about a potential issue concerning the Shoulder Arthroscopy Plate 90568 and 90569.

As part of our Post Market Surveillance we became aware that some Schaerer Shoulder Arthroscopy plates, which have exceeded the 10 years life span, may be affected by corrosion around the holding plugs, which are the interface between the Shoulder Plate and the Surgical Table.

Thus far, one broken plug in a 13 year old plate was reported. The surgeon and the OR staff have managed the incident and the procedure could be completed. The Shoulder Arthroscopy Plate was subsequently taken out of service.

These plates must be taken out of service and replaced by a new model. The local Schaerer Representative will contact you accordingly. Schaerer Medical declines its responsibility for any claims resulting of the further use of these old plates.

Schaerer Medical AG is reducing the patient weight capacity of these plates to 100kg and makes clarifications for the use and maintenance in the user manual. A new label and a revised user manual will be provided.

Furthermore, these plates have to be checked for corrosion and micro cracks of the plugs and the surrounding areas.
