Urgent Field Safety Notice

Medtronic StrataMR Guider Tool

Model #: 45905, Medtronic StrataMR Adjustment Tool Kit

Medtronic reference: FA849

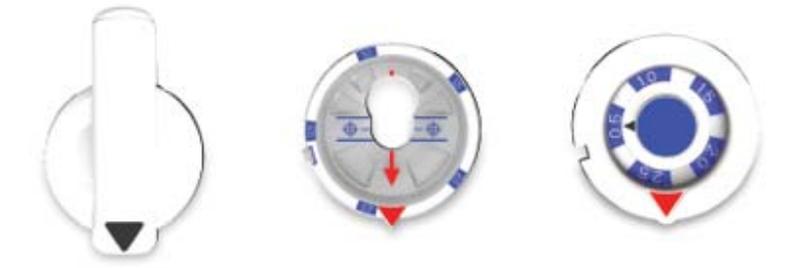
Images of StrataMR Adjustment Tool Set and Guider Tool:

Current StrataMR Adjustment Tool Set Components (Model Number 45905):	New StrataMR Guider Tool (Model Number 45910):

<div style="display: flex; justify-content: space-around; margin-top: 5px;"> ADJUSTMENT TOOL LOCATOR TOOL INDICATOR TOOL </div>

<div style="text-align: center; margin-top: 5px;"> GUIDER TOOL </div>

1. The current StrataMR Adjustment Tool Set is to be converted to include the new StrataMR Guider Tool. Your Sales Rep will perform the conversion to include the new StrataMR Guider Tool to your existing tool set and provide brief instruction on its use.
2. Please refer to the StrataMR Guider Tool Instructions for Use. It is recommended that the Guider Tool be utilized with the complete StrataMR Adjustment Tool set for all pressure adjustments to existing implanted StrataMR valves.
