**Complaint No.**  
KR20180903-1

## **Urgent safety information**

### Recall

### Wheelchair CLEO Ti

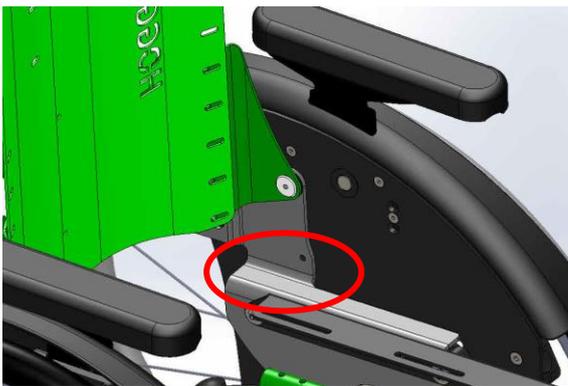
Illustration-1

- HOGGI strives to improve your product quality to ensure the safety of users and their companion in every respect.
- As part of the market observation, HOGGI became aware of a weak point of sheet metal carriers. These are only the seat plate carrier of a certain version and batch. Thus, the amount of affected wheelchairs could be determined. However, not all wheelchairs listed in the attachment are affected. For this reason, it makes sense to send the pictures of the left and right seat plate carrier from each wheelchair listed in the attachment to a dealer or to HOGGI first to identify whether the wheelchair is affected. (which area needs to be photographed is explained below and depicted pictorially).

- After receiving this information, identify the end customer based on serial numbers and commissions in the attachment.
- Immediately inform the end customers to check the seat plate carrier and ask to create the pictures from both sides (which area needs to be photographed is explained below and depicted pictorially).

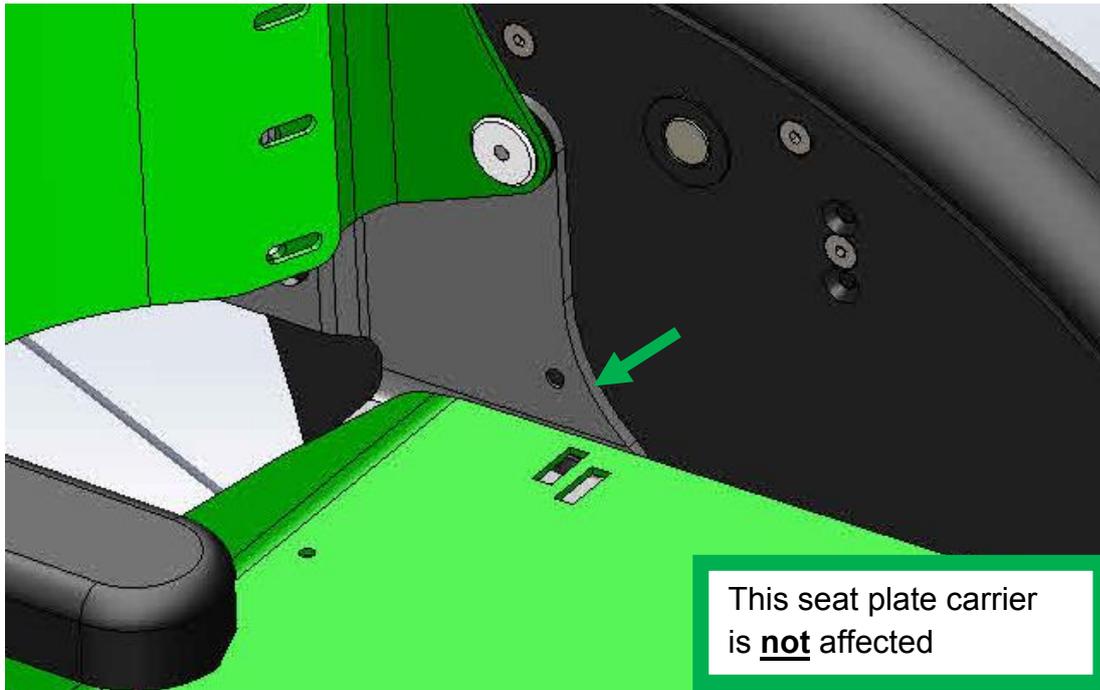
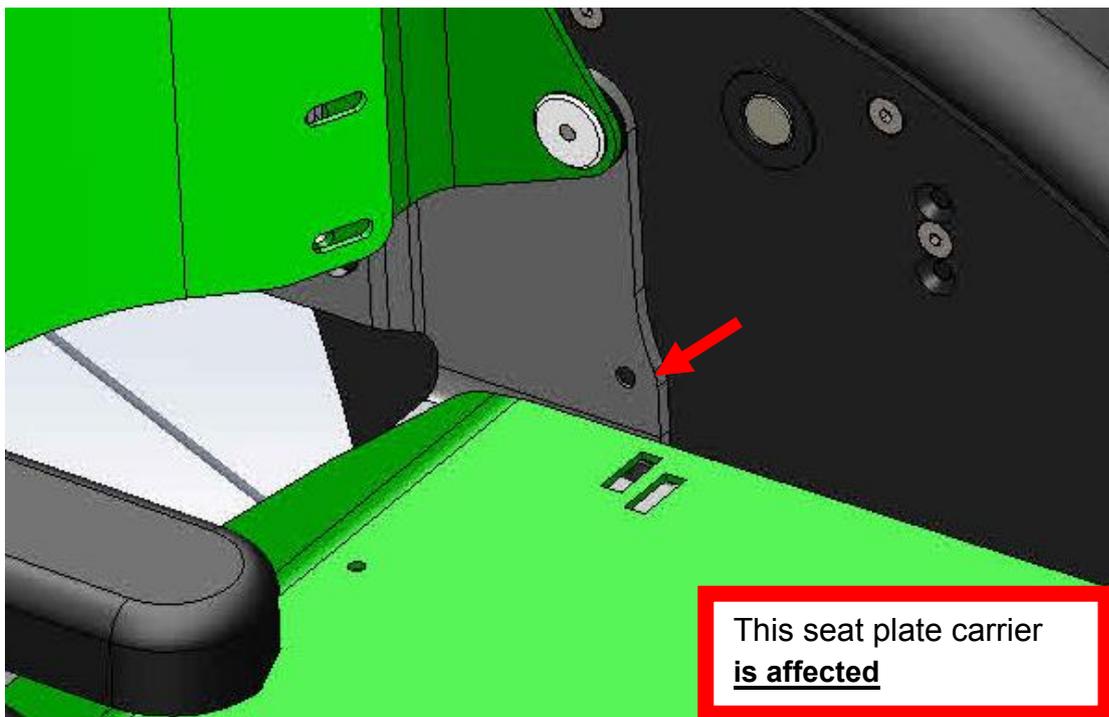
The seat plate carrier is a supporting component to which the seat plate and the back plate are attached. After removing the seat cushion, it is visually recognizable at the radius which seat plate carrier is installed:

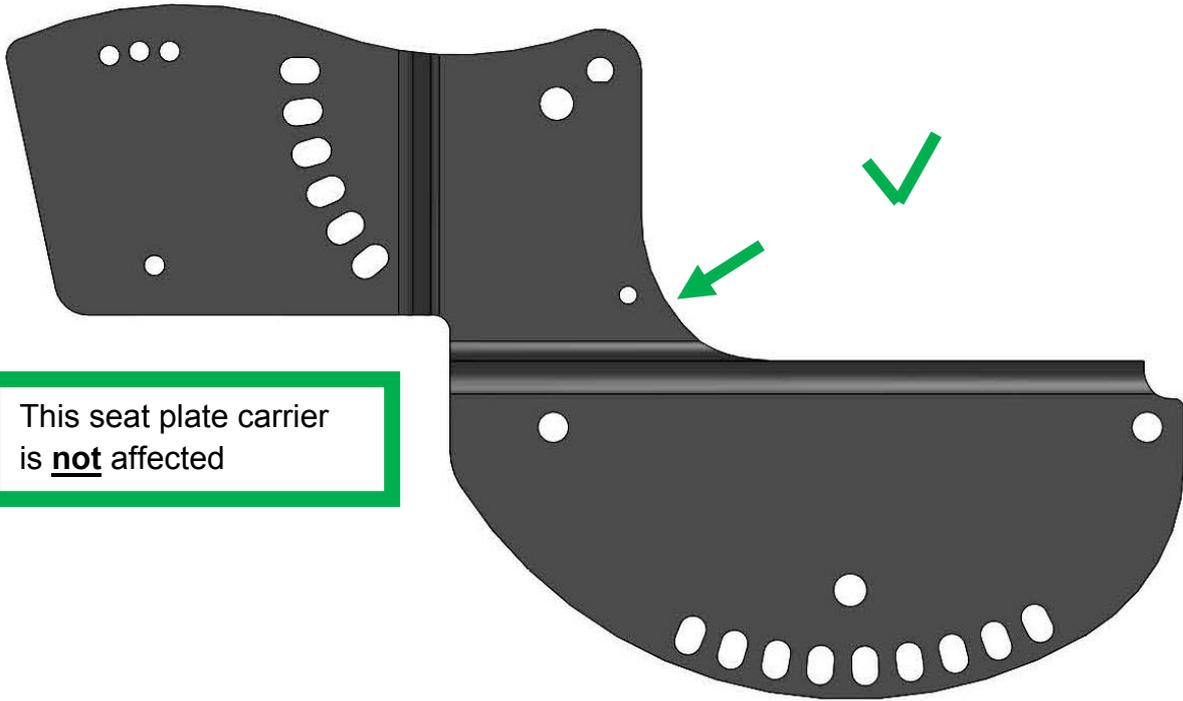
This seat plate carrier  
is **not** affected

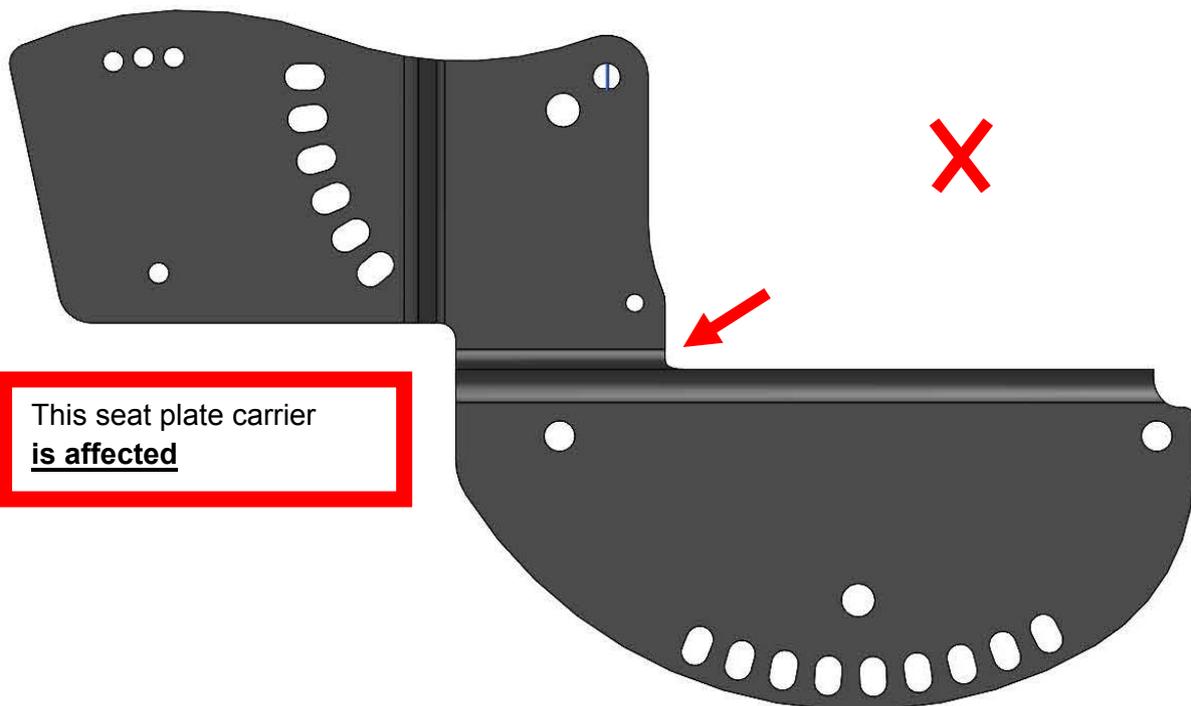
This seat plate carrier  
is **affected**

**Since the risk for users to be injured due to the breakage of the seat plate carrier is too high, seat plate carriers in affected wheelchairs must be replaced as quickly as possible.**

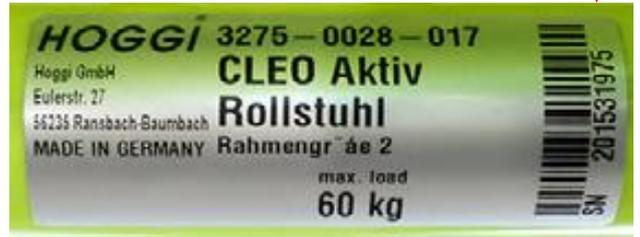
(Serial number can be found here)

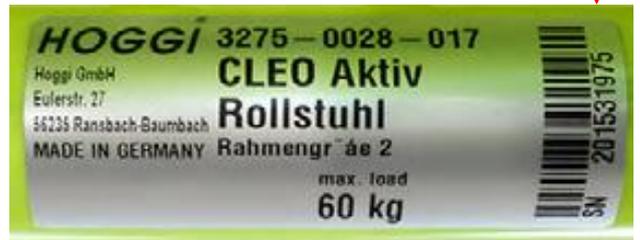
(Serial number can be found here)
