URGENT
FIELD SAFETY NOTICE (FSN)
MEDICAL DEVICE RECALL
MULTIPLE GOLD CUP ELECTRODES and SNAP ELECTRODE LEADS

Date: XXX 2019

Natus reference: CAPA004513

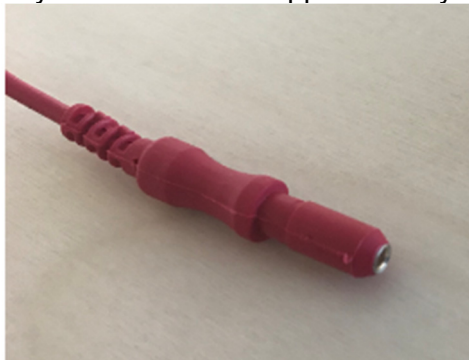
You are receiving this notification because Natus Medical Denmark, going on the market under the GN Otometrics A/S brand name, is conducting a voluntary recall for the gold cup electrodes and electrode leads. Our records show that you received at least one of the gold cup electrodes and snap electrode lead at your location. The electrode lead connector has a protruding conductor beyond insulation of approximately 0.1 mm.

Image 1: Electrode lead connector to main device.

It has been determined that the device does not fully meet the current regulatory standard for basic electrical safety and essential performance. There is a potential risk to the healthcare professional or patient of exposure to electrical shock from the electrode connector.

Natus requests that you do not use the electrode leads and return them.

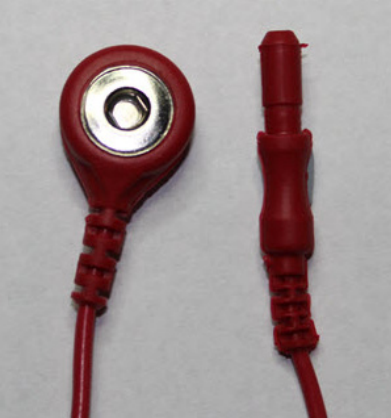
Snap, cable, and connector are all the same color: red, blue, green, brown, orange, white, black, or yellow. The connector has an angled taper as shown in the image below. No text or actual printed/molded identifiers are located on the leads.

Image 2: Snap Electrode lead

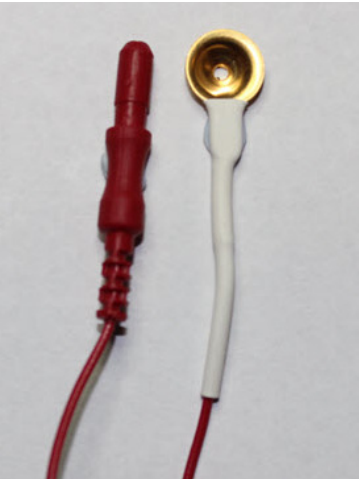
Connector and cable have the same color; there is a white transition between the cup and cable. The connector has an angled taper as shown in the image below. No text or actual printed/molded identifiers are located on the leads.

Image 3: Cup Electrode lead
