URGENT FIELD SAFETY NOTICE

GEHC Ref# 32072

RE: Giraffe Blue Spot PT Lite Phototherapy Systems—Light Output May Fall Below the Recommended Minimum Output Due to Fiber Protrusion.

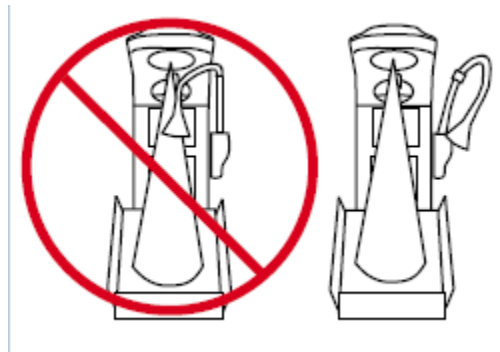
- As previously stated, exposing the shade head to elevated heat from the warmer is contraindicated with this device. To prevent potential damage to light pipes due to elevated heat, we remind that care should be taken to position the light pipe, as shown in the Instructions for Use Section 2.2 "Operation" and in the Quick Reference Guide, keeping the light pipe Shade head outside the direct path of warmers (see figure below).

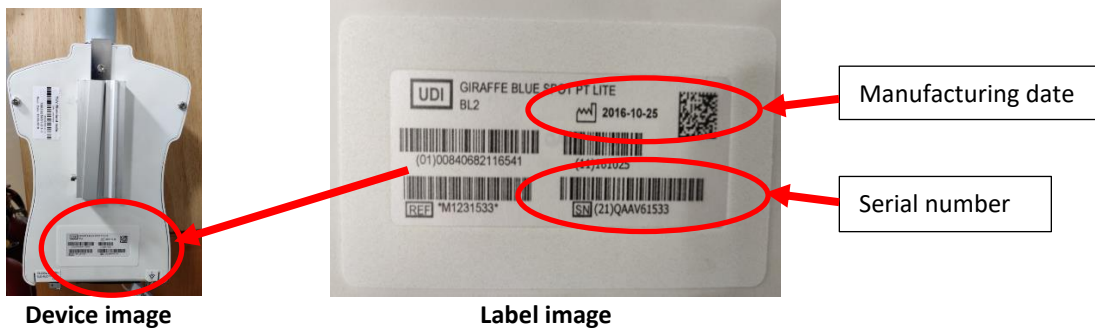
Location of System Serial number and year of manufacturing

System serial numbers beginning with QAAT, QAAU, QAAV, QAAW and QAAX from QAAX60001 to QAAX60155.

System GTIN numbers are 00840682116572 and 00840682116541.

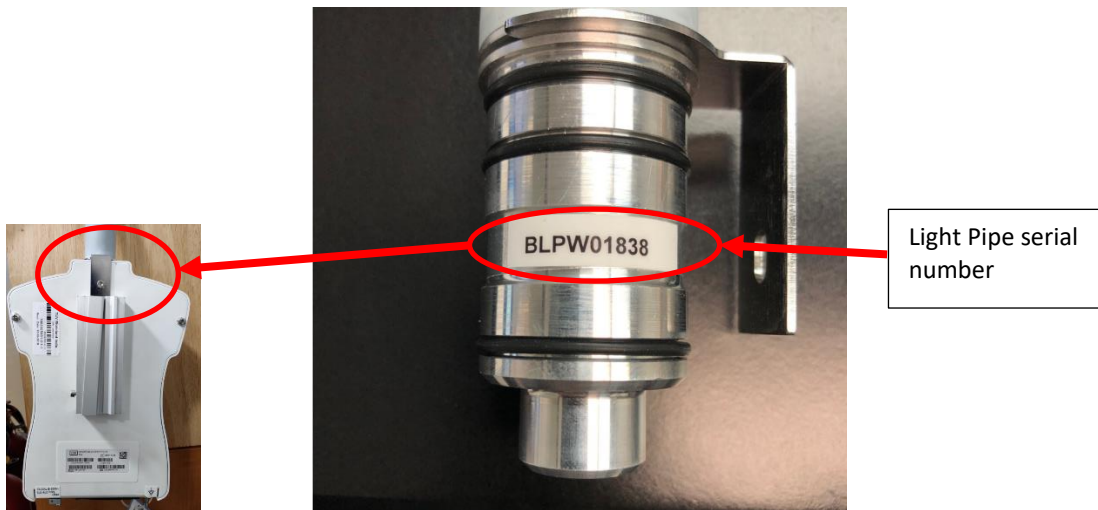
Light pipe serial numbers beginning with BLPT, BLPU, BLPV, BLPW and BLPX from BLPX00001 to BLPX00243.

To locate the Light Pipe serial number, remove the light pipe by referring to Service Manual Section 7.4.1
