URGENT FIELD SAFETY NOTICE
iChemVELOCITY Strips

800-7204	7204285M 7204286A	11-11-2020 11-04-2020

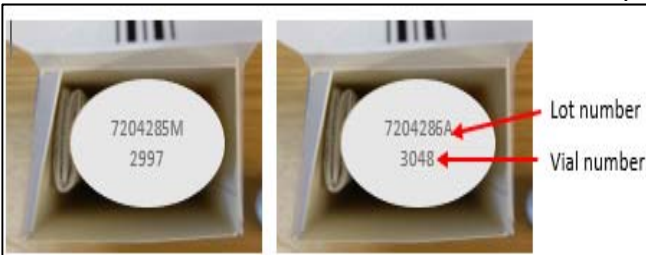
ACTION:	<ul style="list-style-type: none"> Inspect your current iChemVELOCITY Strips inventory to determine if you have any remaining inventory from the affected lots 7204285M and 7204286A. If remaining inventory from the affected lots is found: <ul style="list-style-type: none"> Inspect for the vial number. The vial number is located on the bottom of the vial beneath the lot number, as shown in the example below. <div data-bbox="673 1470 1315 1858" style="text-align: center;">

<div style="display: flex; justify-content: space-around; margin-top: 10px;"> <div style="border: 1px solid black; padding: 5px; text-align: center;"> <p>Lot# 7204285M Affected vials are from <u>2997</u> through <u>3999</u></p> </div> <div style="border: 1px solid black; padding: 5px; text-align: center;"> <p>Lot# 7204286A Affected vials are from <u>3048</u> through <u>3581</u></p> </div> </div> </div>

<ul style="list-style-type: none">▪ If any of the affected vial numbers are found, discard them according to your laboratory protocol.<ul style="list-style-type: none">• Contact your local Beckman Coulter support representative for product replacement.▪ If no affected vial numbers are found continue to use the strips as routine.• Consult with your Medical Director to determine if a retrospective review of results is clinically warranted.
RESOLUTION:	<ul style="list-style-type: none">• Affected product will be replaced.• Beckman Coulter is working to prevent the recurrence of this issue.
