IMPORTANT CUSTOMER INFORMATION

Commercial name of the affected product: IMACTIS CT-Navigation™ Workstation

Description of the problem:

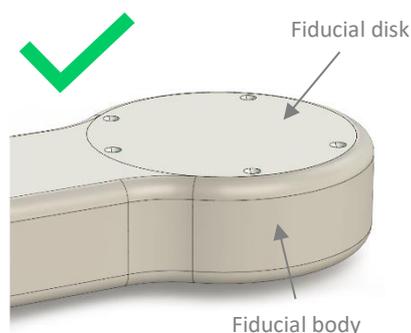
Picture 1. Patient Fiducial Conformity

- 1) Is correctly assembled (See Picture 1) and has not been damaged in any way; or
- 2) Is slightly detached and not flush with the surface (See Picture 2); or
- 3) Has been partially or completely disassembled and then put back in place.

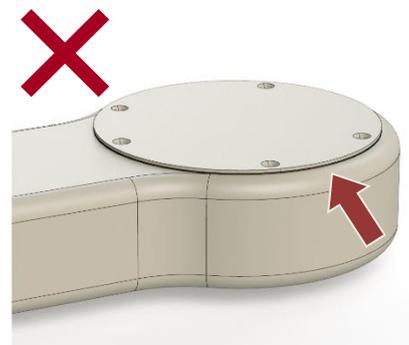
In the event of a shock or fall, the fiducial disk, normally flush with the surface, could become detached from the fiducial body.

Picture 2. Patient Fiducial Non-Conformity

The use of this device under these conditions is not safe. The patient fiducial must be repaired and re-calibrated or should be replaced by an Imactis Field Engineer.

In the event you notice the separation of the fiducial disk, please contact your IMACTIS® representative who will manage the return, repair and recalibration, or the replacement of your patient fiducial.

If you have selected box 2) or 3), do not use the CT-Navigation™ system and contact your IMACTIS® representative immediately.

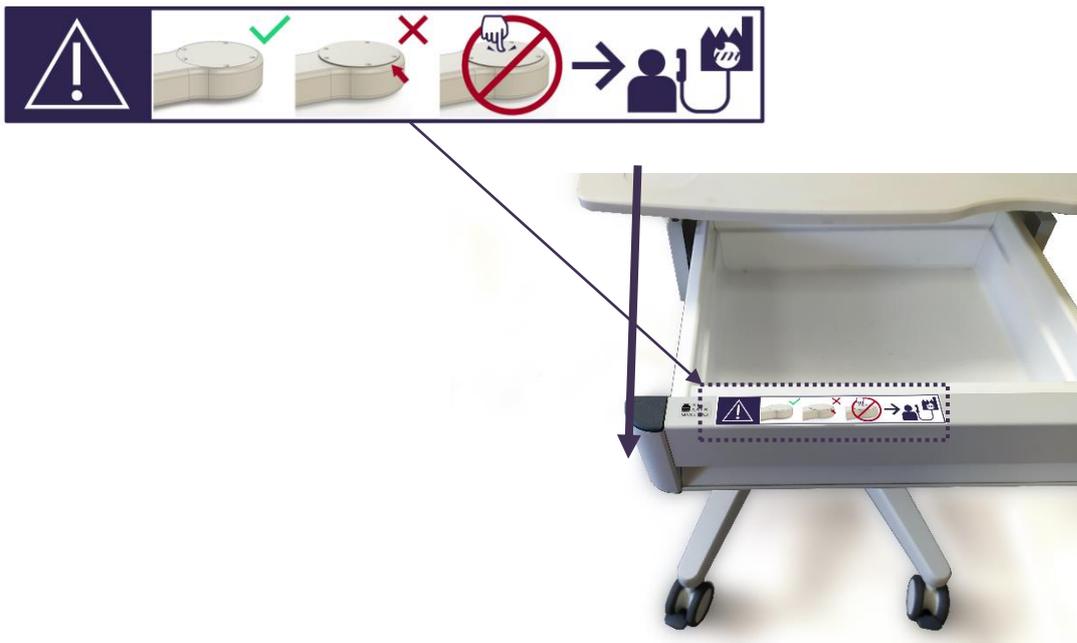
Affix the warning label on the **upper edge of the cart drawer** of the IMACTIS® CT-Navigation™ workstation.
