<u>Urgent Field Safety Notice</u>

Subject: Liko® Multirall™ 200 Q-link strap lock replacement

FSCA-identifier: MOD1322

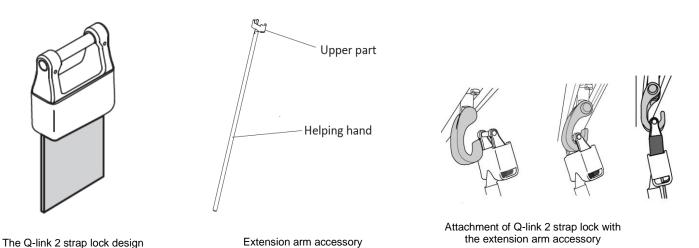
The Q-link II strap lock (illustration below) was introduced on the Multirall overhead lift to resolve ease of use issues with the application of the Q-link strap lock to the \$65 carriage

hook, particularly while applying the Q-link strap lock from the ground level with the Extension arm accessory (illustration below). The Q-link II has a larger opening which allows for better visibility while attaching the hook and the rolling feature of the Q-link II strap lock makes it easier to apply on the \$65 rail carriage hook.

Hillrom will be replacing the Q-link on Multiralls to Q-link II to improve ease of use and mitigate potential risk to patient or caregiver.

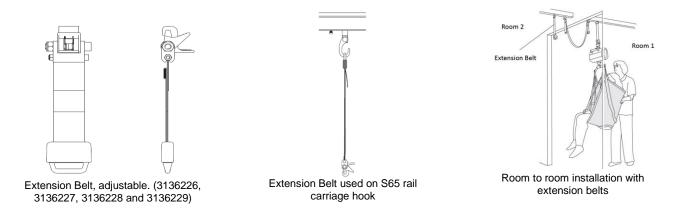
Category B Multirall installations are combined with an extension belt (illustrations below)

Once you have identified units affected by this field corrective action and you have returned the response form, you will be contacted by Hillrom or an official Hillrom distributor, to schedule the replacement of the Q-link 1, R2R accessories and extension belts if present in the installations.
