<Reference: 92659146C-FA>

19 February 2021

Field Safety Notice

Subject: 4G LATITUDE™ MIMIC Cell Adapters. Disposal of a subset of 4G LATITUDE MIMIC Cell Adapters configured incorrectly, Reference 92659146C-FA.

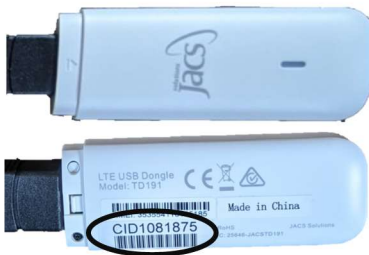
Figure 1. Front/Back images of the 4G LATITUDE MIMIC Cell Adapter, the CID label includes the serial number.

Table 1 describes the affected Cell Adapters and Figures 1 and 2 include images of the product and label.

- 1- Distribute this letter to all other physicians and HCPs within your organization who need to be aware of this topic.
- 2- Immediately segregate all affected 4G LATITUDE MIMIC Cell Adapters in your inventory (see Table 1 and Appendix A) and dispose of (scrap) them locally (there are no special disposal requirements).
- 3- Contact patients that have received a 4G LATITUDE MIMIC Cell Adapters and instruct them to dispose affected Cell Adapters.
- 4- Complete the enclosed Acknowledgement Form and send it back to Boston Scientific for the attention of «**Customer_Service_Fax_Number**» on or before **8 March 2021**.

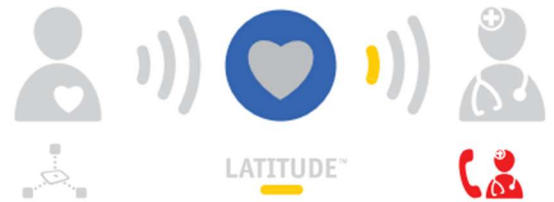
Figure 3. Top: If data transmission is unsuccessful connecting to the LATITUDE System, the Communicator will display one yellow sending wave. Bottom: If a CIED alert condition is not transmitted, the Communicator will display a Red Call Doctor icon.

- If a Communicator configured to the patient's CIED is unable to successfully transmit data, the communicator will display one yellow sending wave (see Figure 3 top image).
- If an CIED red alert condition was not transmitted, the Communicator will prompt the patient within 24 hours to call their HCP via the Red Call Doctor icon on the Communicator (see Figure 3 bottom image).
- If the Communicator is unable to transmit data to the LATITUDE System, the HCP will be informed via LATITUDE after 14 days.
