**Urgent Field Safety Notice**

**Ambu® SPUR® II for Demand Valve**

**Ambu A/S - Single Registration (SRN): DK-MF-000001437**

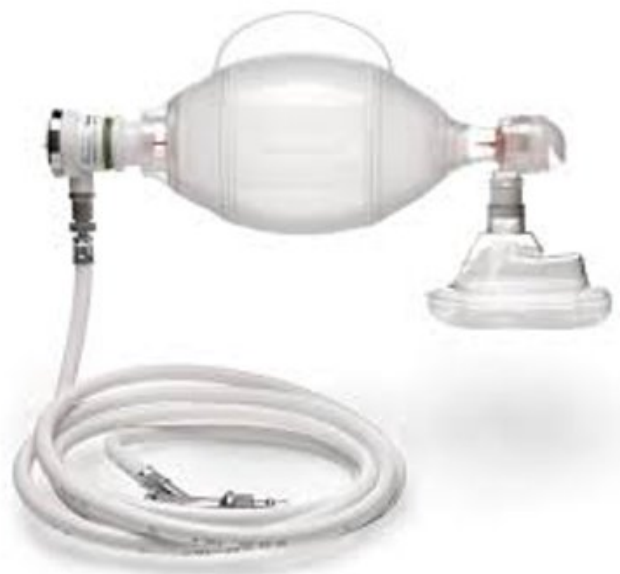
**Ambu® SPUR® II for Demand Valve**

The oxygen connector on the Ambu SPUR II for demand valve can in very rare cases deteriorate during storage and present as collapsed. If a SPUR II for Demand Valve version with a collapsed oxygen connector is put into use, it will not be possible to provide the patient with additional oxygen from the oxygen reservoir. Additional oxygen can still be provided through the demand valve and ventilation with ambient air is still possible.

The traceability system at Ambu indicates that your institution has purchased the SPUR II for Demand Valve device produced between December 2014 and February 2019 and there may be affected devices in your stock. You should address this by discarding affected LOTs of the Ambu SPUR II for Demand Valve devices according to local regulations.
