Subject: Compella- Exposed AC Power Conductors

Product	Model	Manufacturing Dates
Compella™ Bariatric Bed System	P7800A	All beds manufactured
Compella Therapy Air Supply Unit	P7810A	All Air Supply units manufactured

FA Number: FA-2021-12-003-BAT-008

Advisory Notice

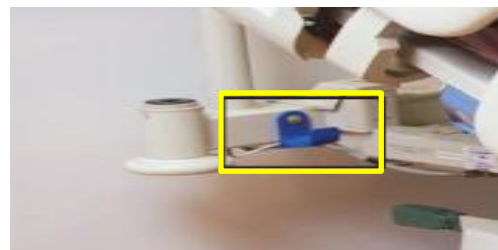
Fig. 1- Compella Cord Hooks.

There are two blue hooks on the inside of the head-end frame to stow the power cords for transport. Wrap the cords around the hooks so that they do not drag on the floor. (Fig 1.)

To help prevent personal injury and/or equipment damage, before you transport the bed, make sure that the power cord, hoses, and other equipment are correctly stowed.
