Field Safety Notice

FSCA-identifier FSCA-2022-05-16-A

Type of action Destruction of product following previous quarantine

Annex 1: Examples of Product Labelling

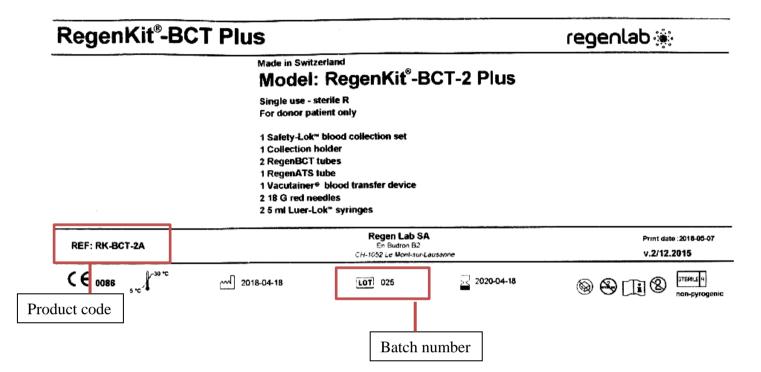
Labeling printed on Tyvek

See Annex 1 for example of package labeling that highlights the location of the product code and batch number on the device label which is located on the primary packaging. The product code (reference number) is preceded by the word "REF" and the batch number is preceded by word "LOT".

For a destruction, the only way to identify affected products is by comparing product code and batch number to the destruction product list (see table above).
