## URGENT Field Safety Notice

### Incisive CT & CT 3500 System

Potential for Incorrect Image Orientation

10-Apr-2023

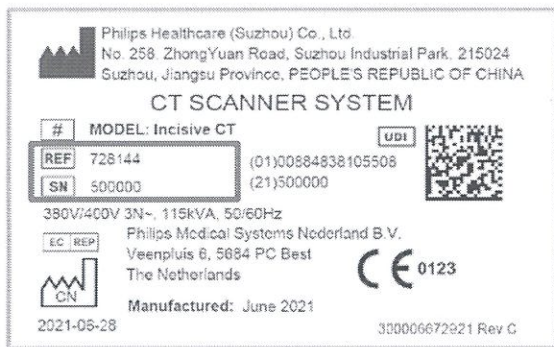
Figure 1. Incisive CT System Label Example

To determine if your product is impacted, refer to the system label (Figure 1 & 2) located on the back left corner of the gantry.

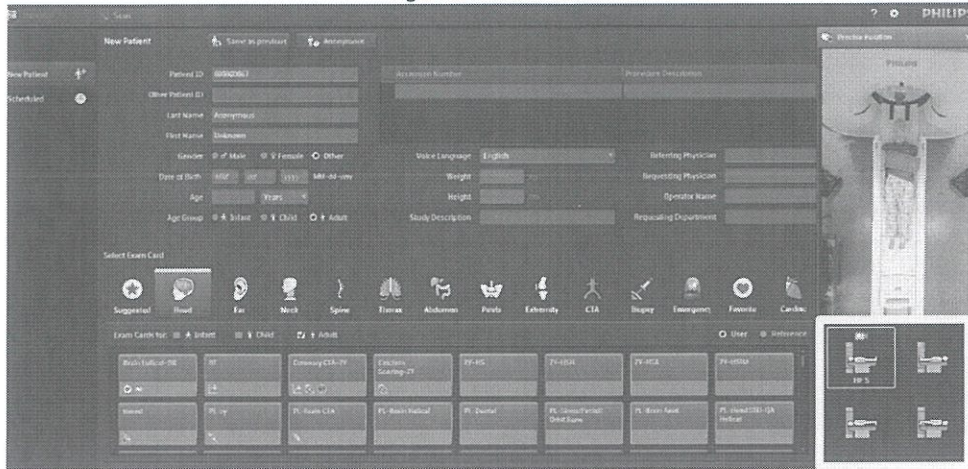
Figure 3. Precise Position

- Refer to the IFU of your Incisive CT / CT 3500 system to ensure proper use of the Precise Position function (IFU Section 4.9).
- If the patient orientation automatically selected by Precise Position (see Figure 3) is inconsistent with the preset protocol, please correct the settings as described below:
  - Manually select the correct orientation in the **Select Patient Orientation** area in the **New Patient** interface, or
  - Open the **Select Patient Orientation** list by clicking the patient orientation icon in the left upper corner of the series list and select the correct orientation.

Philips will contact you to schedule a time for a Field Service Engineer (FSE) to visit your site and install a software upgrade to address the issue (reference FCO72800793 for Incisive CT system and FCO72800797 for CT 3500 system).
