URGENT FIELD SAFETY NOTICE

GE HealthCare Ref. # 79072

RE: **Double image artifact with IC9-RS intracavitary probes**

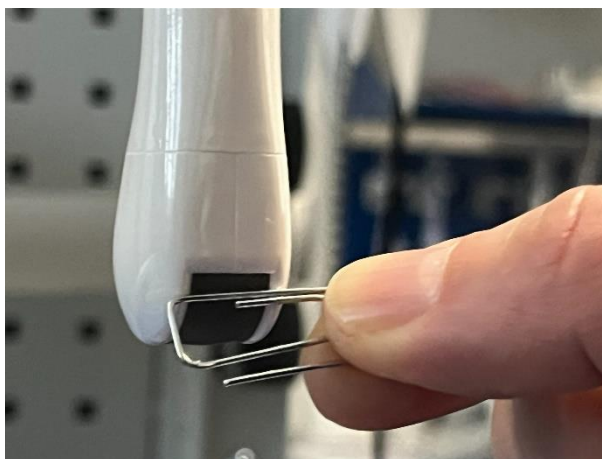
1. Run the edge of a smooth, metal reflector (paperclip, metal pen, flat side of tweezers or similar) along the probe lens starting at the edge of the field of view and running it along the full curvature of the probe (Figure 1).
2. The metal reflector will produce strong echoes localized at the point of contact.
3. To enhance the echoes, apply a smear of water on the metal reflector only.

Figure 1: Double image test procedure. Place metal reflector (paperclip shown) at the edge of the field of view. Run reflector along the full curvature of the transducer.

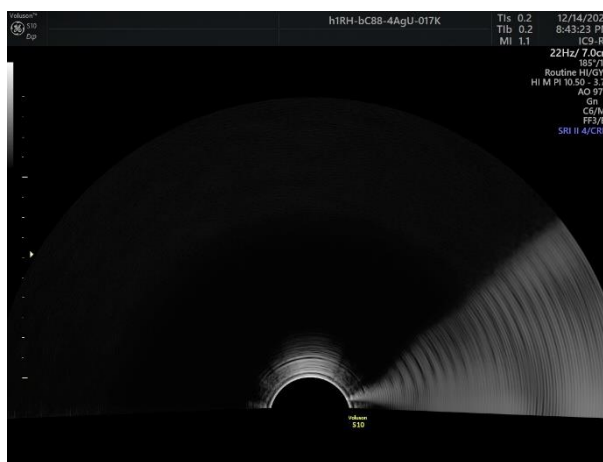
Figure 2. Test image from a normal IC9-RS probe. No artifact visible.

If an additional echo is seen in the sector opposite of the point of contact, the probe is producing a double image artifact. Double image artifacts are only visible towards the edges of the field of view. See test images below from a normal IC9-RS probe (Figure 2) and a malfunctioning IC9-RS probe producing double image artifact (Figure 3).

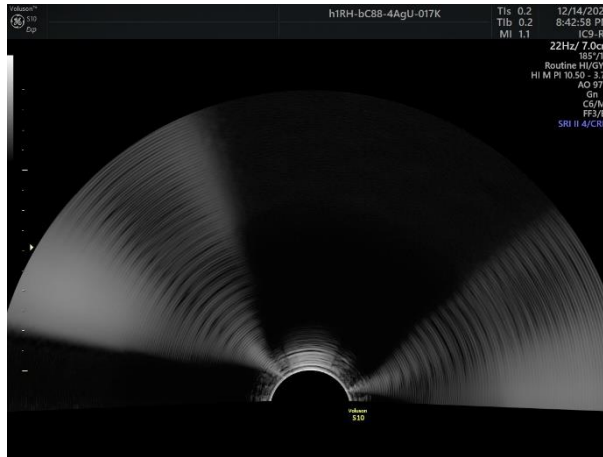
Figure 3. Test image from a malfunctioning IC9-RS probe showing double image artifact in the opposite sector.

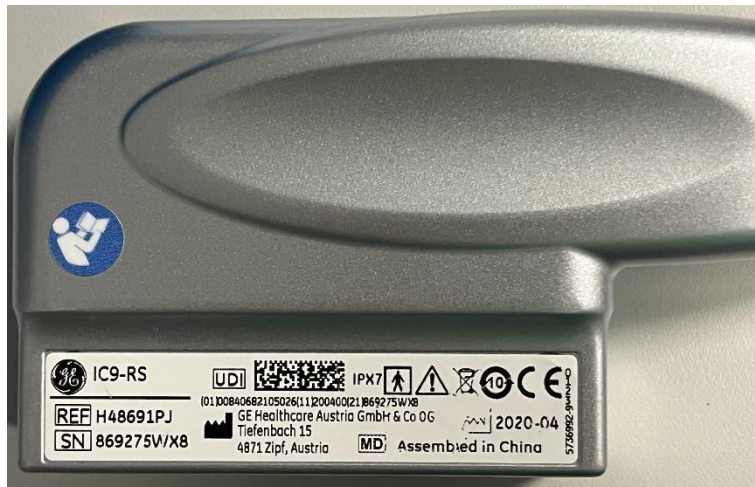
Figure 4. Rating plate example – displaying probe type (IC9-RS) and serial number (SN).

IC9-RS probes with a serial number included in Appendix A are affected by this issue. The serial number (SN) can be found on the rating plate as shown in Figure 4
