## Urgent Field Safety Notice (FSN)

Replacing the power supply unit  
for care beds in the Ecofit range

13.05.2024

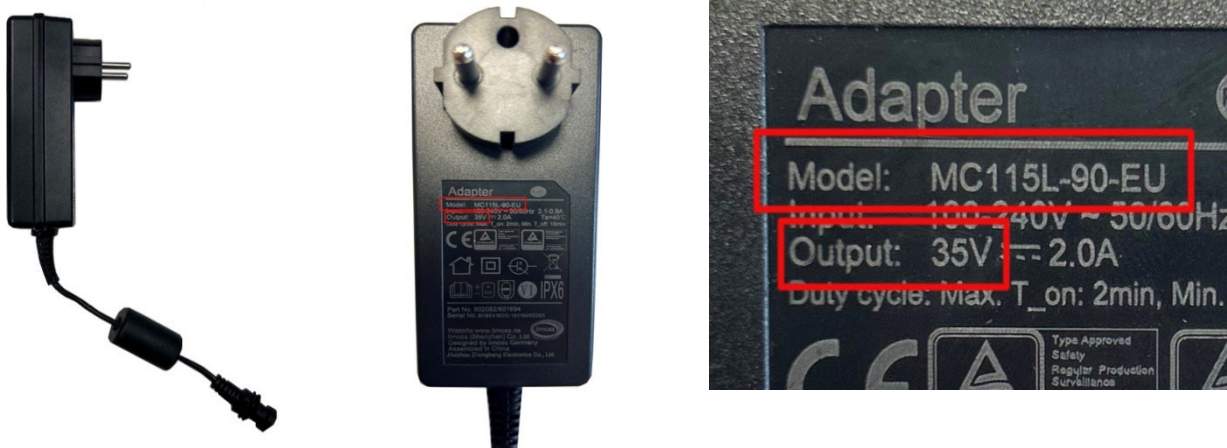
This only applies to Ecofit care beds with the built-in power supply unit **MC 115L-90-EU** (manufacturer limoss GmbH) and an output voltage of **35V**. The attached list shows the serial numbers of all products (see cover sheet) for which the power supply unit needs to be replaced.

Please replace the MC115L-90-EU power supply unit with the PS1102 power supply unit provided free of charge by tecfor care for care beds from the Ecofit range in your inventory or during the next maintenance. Instructions for replacement can be found in the appendix to this letter.

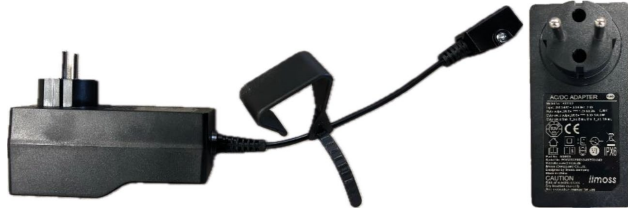
#### Scope of delivery:

**Plug-in power supply SMPS - PS1102**

200-240V, 50-60Hz, 2,4A, IPX6

Model number: 503605

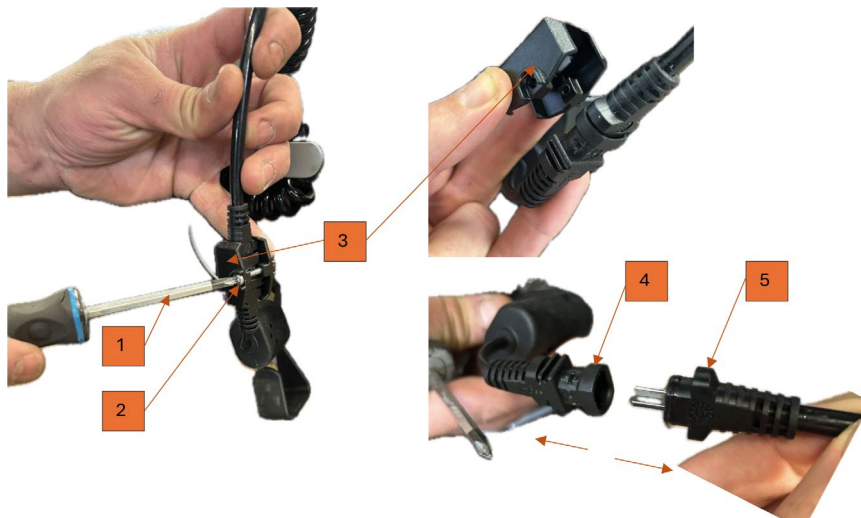
1. To remove the previously installed power supply unit, use a screwdriver (1) to loosen the screw (2) on the safety cap of the plug connection.
2. You can then remove the protective cap (3) with little effort.
3. Now release the plug connection (4+5) by pulling in the opposite direction.

1. Take the new plug from the scope of delivery and fit it in the opposite direction as described in the "Disassembly" section.
2. Once steps 3-1 have been carried out, the power supply unit is ready for use and can be reconnected to the mains supply.
