Updated Field Safety Notice

Height Adjustable (HA) FlexTrak Trolley

Potential falling hazard resulting from HA FlexTrak Trolley oil leakage

October 15, 2025

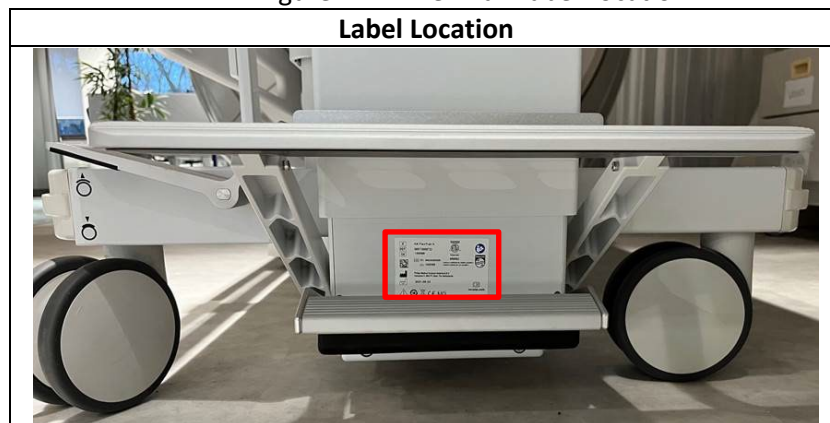
Figure 2. HA FlexTrak Label Location

The HA FlexTrak identification label is positioned on the handgrip side of the trolley below the pump pedal, as shown in Figure 2.
