## Urgent Field Safety Notice (FSN)

Replacing the power supply unit  
for care beds in the Ecofit Xtra range

24.05.2024

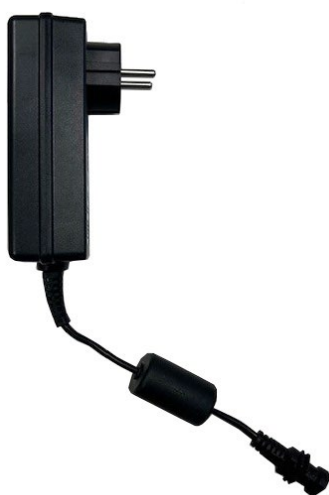
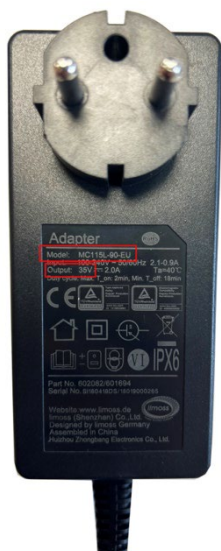
This only applies to Ecofit Xtra care beds with the built-in power supply unit **MC 115L-90-EU** (manufacturer limoss GmbH) and an output voltage of **35V**. The attached list shows the serial numbers of all products (see cover sheet) for which the power supply unit needs to be replaced.

Please replace the MC115L-90-EU power supply unit with the PS1102 power supply unit provided free of charge by tecfor care for care beds from the Ecofit Xtra range in your inventory or during the next maintenance. Instructions for replacement can be found in the appendix to this letter.

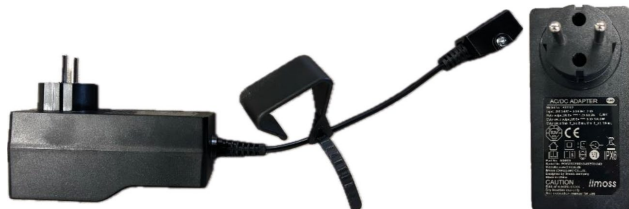
#### Scope of delivery:

**Plug-in power supply SMPS - PS1102**

200-240V, 50-60Hz, 2,4A, IPX6

Model number: 503605

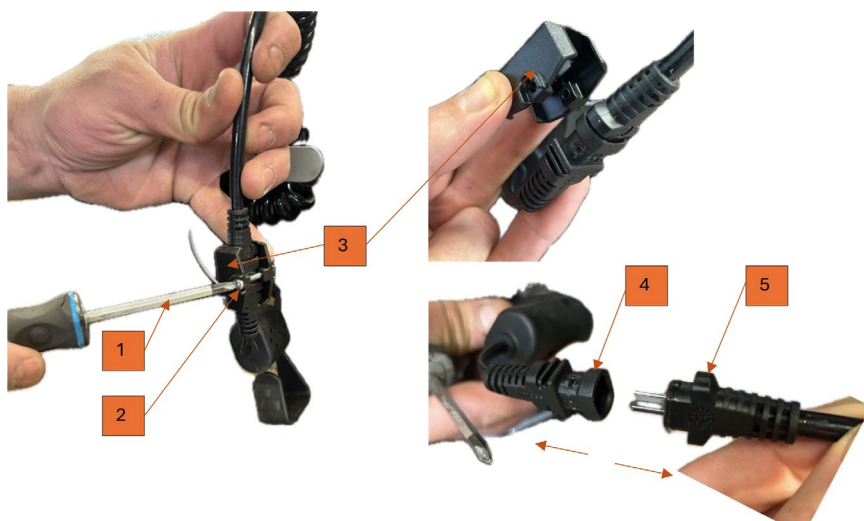
#### Dismantling:

1. To remove the previously installed power supply unit, use a screwdriver (1) to loosen the screw (2) on the safety cap of the plug connection.
2. You can then remove the protective cap (3) with little effort.
3. Now release the plug connection (4+5) by pulling in the opposite direction.

1. Take the new plug from the scope of delivery and fit it in the opposite direction as described in the "Disassembly" section.
2. Once steps 3-1 have been carried out, the power supply unit is ready for use and can be reconnected to the mains supply.
