Urgent Field Safety Notice

SBN-CPS-2018-002

cobas e 801 syringe plunger issue

Product Name	cobas® 8000 modular analyzer series cobas e 801 module
Affected Instrument Part GMMI / Part No	PLUNGER (798-3203)
Instrument/System Affected	cobas e 801 module (GMMI 07682913001) from serial numbers 1601-01 to 18E6-10
SW Version	Not applicable
Type of Action	Field Safety Corrective Action (FSCA)

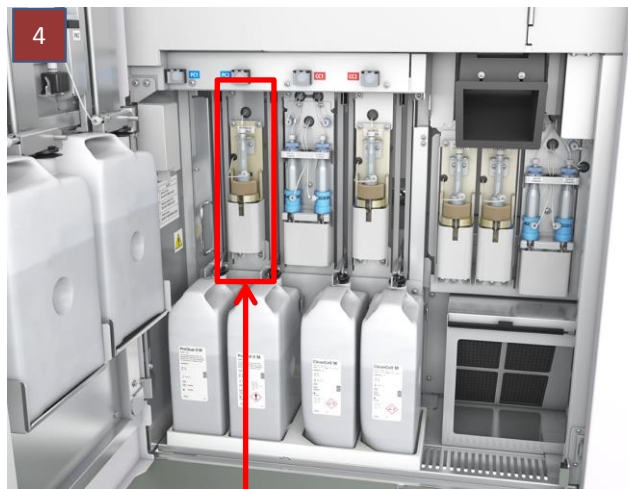
Pre-wash syringe

- 5 To check the proper condition of the Pre-wash Syringe, open the **cobas e 801** module front cover. Visually verify that the white Plunger of the Pre-wash Syringe is moving up and down while the Pre-wash Unit is working. The stroke of the Plunger is not a performance relevant criterion.

Important: If a damaged PreWash syringe plunger is identified (see the above procedure, step 3), stop using the **cobas e 801** module and immediately contact Roche Customer Support. In addition, do not validate the measured results and repeat the measurement of concerned samples.
