## FIELD CORRECTIVE ACTION NOTICE

Leica M525 F20 Microscope System

FCA Identifier: CAPA-HER-MD-18-001

Enhancement of instructions for use and additional markings to prevent inadvertent tipping

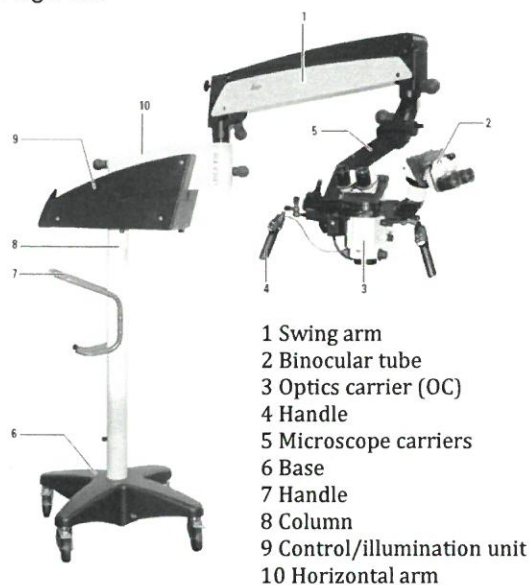
Figure 1: Overall view of Leica M525 F20 Microscope

This letter is to inform you about a field corrective action involving all Leica M525 F20 Microscope Systems (see Figure 1) to replace the instructions for use with an enhanced revision and to fix additional markings onto the device.

Leica Microsystems received five customer complaints stating that users inadvertently tipped over their Leica M525 F20 Microscope System. In four cases it was confirmed, that the issue occurred when users handled the microscope while the swing arm was in fully extended position (see Figure 3). In all cases the Leica M525 F20 did not cause or contribute to serious injury. The five complaints occurred in five different countries over a timeframe between the years 2010 and 2017. The Leica M525 F20 was introduced in the year 2009 with more than 1000 instruments distributed globally up to date.

Leica Microsystems identified an area of improvement in the instructions for use and markings as root cause for the reported issues. The existing instructions for use and markings on the device need to be elaborated in an enhanced manner to ensure all users will position and handle the Leica M525 F20 as intended with an angle of approximately 90° between horizontal arm and swing arm (see Figure 2). When the Leica M525 F20 is positioned with an angle of approximately 90° between horizontal arm and swing arm it is unlikely that the instrument is inadvertently tipped over by a person handling the instrument.
