IMPORTANT FIELD SAFETY NOTICE

CentriMag™ Acute Circulatory Support System Motor Model: 201-10002
Compatible with CentriMag™ Pump and PediVas™ Pump

September 5, 2018

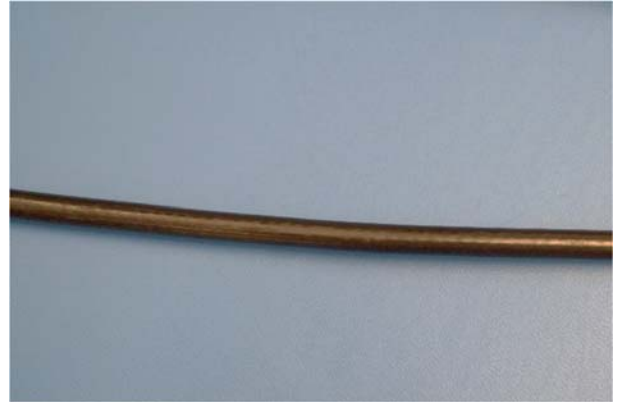
Figure 6: Undamaged and Intact Motor Cable

2. Visually inspect the entire length of the CentriMag Motor cable, including both bend reliefs (see Figures 3 and 4), for any damage such as separations of the bend reliefs, deformations, kinks, or cuts. These types of damage indicate wear and tear or previous rough handling of the cable, which has the potential to result in internal wire damage. Cable thickness and shape should be uniform throughout the length of the cable.
