URGENT MEDICAL DEVICE CORRECTION**September 10, 2019****To:** Hospital/Surgeon Name**Affected Product:** ROSA Brain 3.0

Medtech S.A - Zimmer Biomet - is initiating a medical device Field Safety Corrective Action for ROSA Brain 3.0 products. This notice informs you of the issue and the corrective actions Zimmer Biomet is taking.

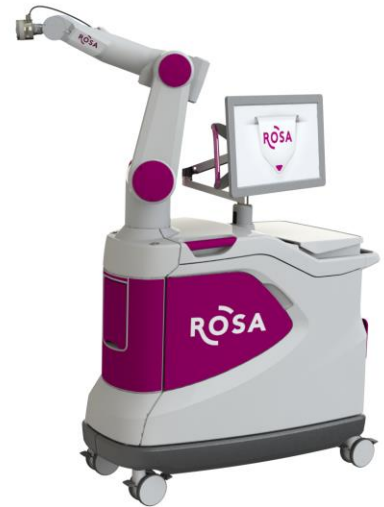
*ROSA Brain 3.0***Description of the issue:**

Zimmer Biomet is aware of events where the ROSA Brain 3.0 instrument holder was sent on a trajectory that is not within the intended target. The robot arm is intended to position the instrument holder on the selected trajectory so that rigid neurosurgical instruments such as drill bit, screwdriver, cannula, etc. - are inserted through the adaptor to perform the intended surgical procedure.

While the incorrect trajectory was detected in all reports received to date (e.g. the robot arm is at an unusual distance from the patient's head, or the instrument is not at the correct position), if it is not corrected, the associated device may be placed incorrectly (e.g. the anchor bolt). Failure of the device to move to the correct trajectory, if not identified by surgical staff, could result in serious injury or death.

After the registration of the patient within the ROSA Brain 3.0 device, the issue may occur only in the guidance mode (e.g. when the robot arm is on trajectory), when the user selects the optical distance sensor and sends the robot arm on each entry point, and then selects the instrument holder. In such case, the use of the "Undo" button in the Tool installation panel will result in the issue due to a software anomaly.
