Philips Image Guided Therapy Corporation  
**URGENT Field Safety Notice**  
Philips Laser System (LAS-100) Error 500

JUN-2022

Reference: LAS-100 Error 500, 2022-IGT-IGTD-002

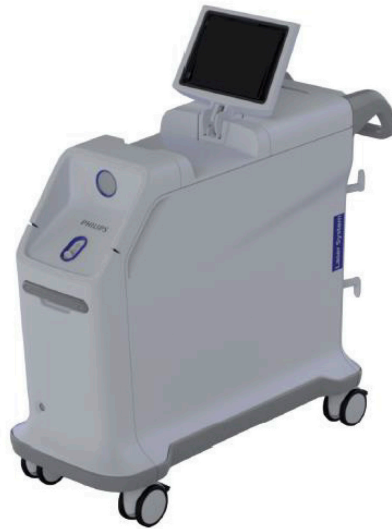
Figure 2: LAS-100 Philips Laser System

The LAS-100 Philips Laser System (see Figure 2) is used in minimally invasive interventional procedures within the cardiovascular system, and for the removal of pacemaker and defibrillator cardiac leads.
