## Urgent Field Safety Notice

July 2022

**Subject: Field Safety Notice** – Continued use of older Model 2868 software on Model 3120 ZOOM™ programmers to support transvenous CRT-Ds and ICDs until supply chain constraints on newer programmers<sup>1</sup> are resolved. See Appendix A for affected GTINs (Boston Scientific Field Action Reference: 92822246-FA)

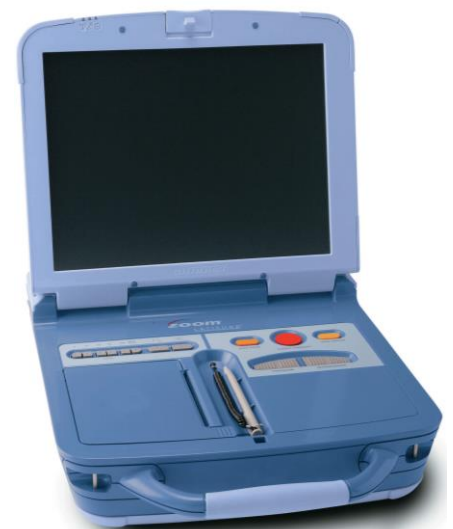
**Figure 1.** Model 3120 ZOOM Programmer

- Global supply chain challenges have constrained availability of the newer programmers.
- Until the supply chain constraints are resolved locally, you may continue using older 3120 ZOOM programmers.
- The 2868 software on the 3120 ZOOM programmer has been uninstalled or is outdated. As such, users may observe unexpected behaviors when attempting communications with transvenous defibrillators<sup>2</sup> including the potential inability to interrogate or the display of incorrect/missing parameters<sup>3</sup>
- A software update has been developed to resolve some of the disruptive behaviors associated with continued use of 2868 software on the 3120 ZOOM programmer. Boston Scientific will release software after local approval.

In facilities whose 3120 ZOOM programmers still have 2868 software installed, there may be unanticipated behaviors observed when interrogating TV defibrillators. The most common behavior observed is an inability to interrogate a TV defibrillator due to a Signal Artifact Monitor (SAM) episode. SAM is one of the new TV defibrillator features included in the enhanced software found on the 3300 LATITUDE programmer. SAM is designed to continually monitor the electrogram for Respiratory/Minute Ventilation (MV) sensor artifacts. If artifacts are detected or sensor vector lead impedance measurements are out of range, SAM either switches the vector or disables the sensor, and a SAM episode is recorded.

- The risk of insufficient programmer supply outweighs the risks associated with these unexpected behaviors, therefore, Boston Scientific recommends continued use of 3120 ZOOM programmers for transvenous defibrillators until sufficient supply of the newer programmers can be achieved locally.

**Recommendations:** Please distribute this letter to all users of the 3120 ZOOM programmer and complete/return the Acknowledgment Form. Continue using 3120 ZOOM programmers to interrogate Boston Scientific TV defibrillators, as needed, with the following in mind:
