Urgent Field Safety Notice

Affinity Fusion™ Oxygenator Temperature Monitoring Adapter Notification

February 2023

Medtronic Reference: FA1302

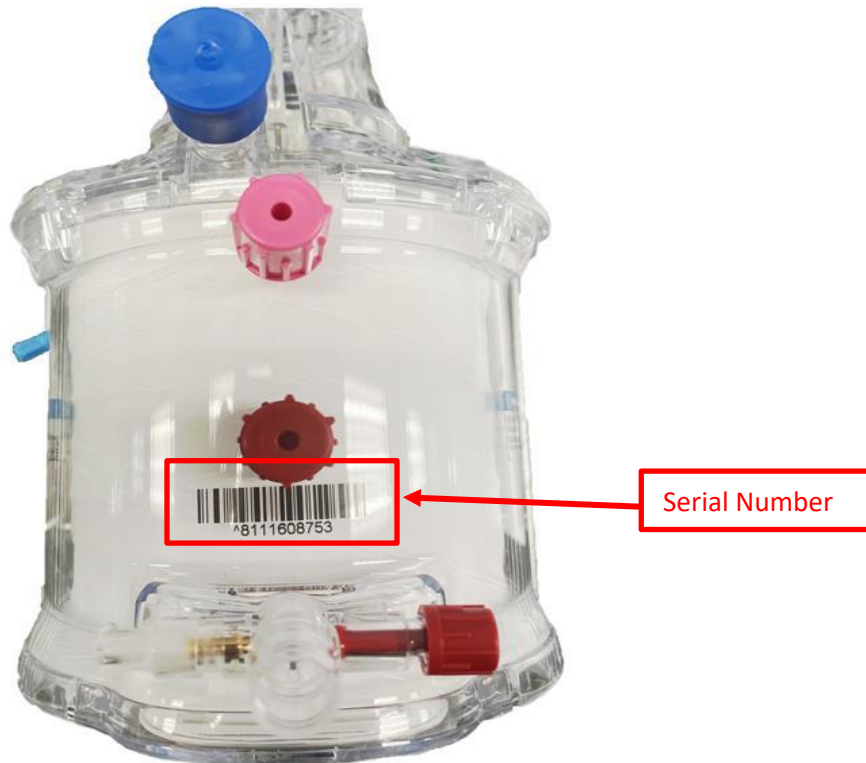
Image 2 - SN location on the Affinity Fusion Oxygenator

At time of set up, locate the serial number on the affected product by referring to the image below.
