FSN Ref: 2023-11(01)
Date: 01 Dec 2023

Urgent Field Safety Notice (FSN)
Mölnlycke® Procedure Trays
Dispo Medical Insufflation tube within Mölnlycke® Procedure Trays

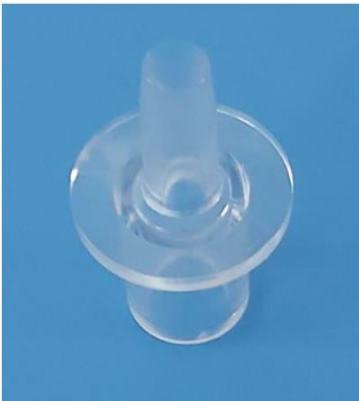
1.	<p>4. Device Model/Catalogue/part number(s)</p> <p>See Appendix I Product Table</p>
1.	<p>5. Affected serial or lot number range</p> <p>See Appendix I Product Table</p>
2 Reason for Field Safety Corrective Action (FSCA)	
2	<p>1. Description of the product problem*</p> <p>Mölnlycke has recently been informed of an action initiated by Dispo Medical, who is the legal manufacturer of the device listed above. The issue is relating to an error which occurred during the injection moulding process of one of the filter connectors during production. A relatively small part of these connectors appears to be impenetrable and is blocked from the inside by an occluding fleece, as picture 1 below.</p>

<p>Picture 1 – Incorrect filter connectors with occluding fleece.</p> <p>These faulty connectors may be incorporated into some of the Dispo Medical devices, which Mölnlycke subsequently includes in Mölnlycke® Procedure trays.</p> <p>Mölnlycke has decided to follow the legal manufacturer FSN and perform a Field Safety Corrective Action. At the point of use of these Mölnlycke® Procedure trays, the user is required to identify the affected component 2323184-00 (Insufflation tube) and check whether the connector is open. If you encounter a blocked connector, please discard, and inform vigilance@molnlycke.com</p>
2	<p>2. Hazard giving rise to the FSCA*</p> <p>Information from Dispo Medical:</p> <p>There is no immediate danger to the patient, however the product will not function due to the fact gas cannot flow through it. A blocked connector will cause discomfort during use and may delay the procedure using the medical device in question.</p>

<p style="text-align: center;">3. Type of Action to mitigate the risk</p> <p>3. 1. Action To Be Taken by the User</p> <ul style="list-style-type: none"> <input checked="" type="checkbox"/> Identify Device <input checked="" type="checkbox"/> Quarantine Device <input checked="" type="checkbox"/> Take note of amendment: affix a copy of this FSN to each Mölnlycke® Procedure tray and make this FSN information available for the user <p>We need your help in ensuring that <u>all affected products</u> are located and that below actions are performed.</p> <p>Please follow below instructions:</p> <ol style="list-style-type: none"> 1. Identify and isolate the unused Mölnlycke® Procedure Trays at your facility, please see Appendix I for affected product information. 2. Affix a copy of this Field Safety Notice (FSN) to each Mölnlycke® Procedure tray and make sure that its contents is brought to the attention of all relevant personnel to read before use. 3. At the point of use of the tray, the user is required to check whether the connector is open. If you encounter a blocked connector, please discard, and inform vigilance@molnlycke.com 4. Fill out the Customer Reply Form or Distributor Reply Form with the quantity of identified affected products. Please sign and email/fax the Customer Reply Form or Distributor Reply Form per its instructions within 10 business days.
