**MEDICAL DEVICE CORRECTION NOTIFICATION
FIELD SAFETY NOTICE**

Subject IGC PCB (for TrueBeam installations only) does not provide an RTInterface error in the event of an I/O error between the IGC PCB and the Framegrabber PCB

Commercial name of product: AlignRT

Reference/FSCA identifier: 3004832819-07/25/18-001-C

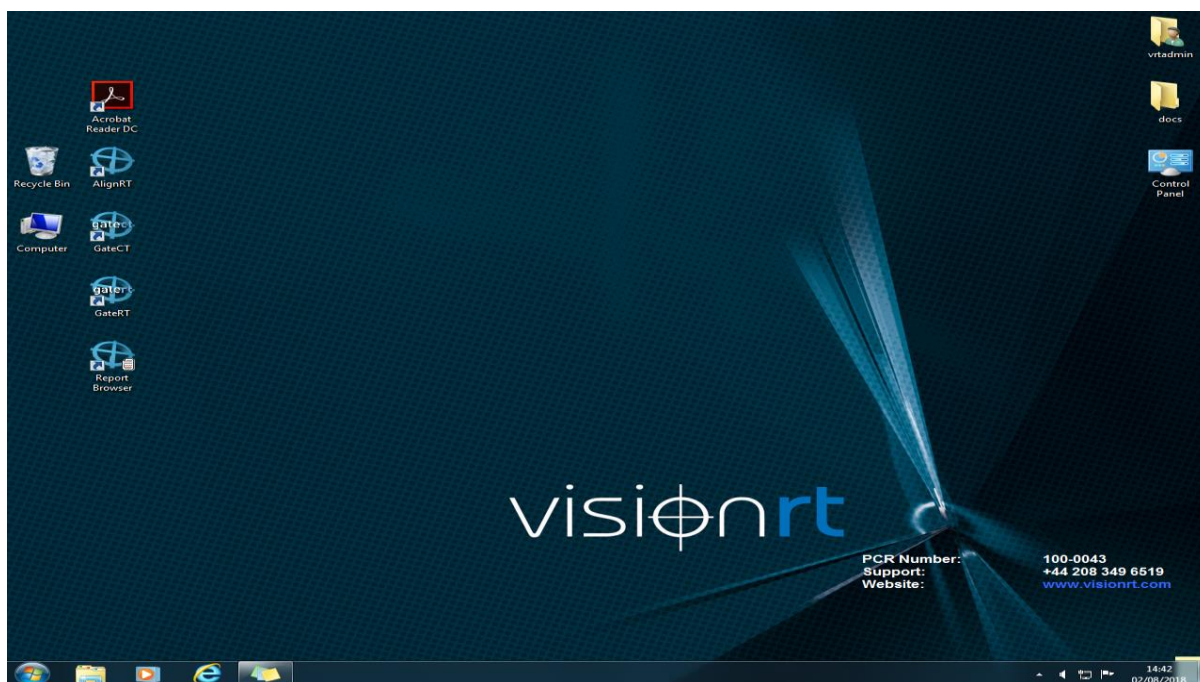
Once the application has been closed, the Windows® desktop will be shown, an example for AlignRT is shown below:

Figure 2 - Typical Desktop Showing AlignRT Has Been Closed

IMPORTANT – ensure that the application has been closed and not simply minimised. Check this by ensuring that the application is NOT shown in the task bar at the bottom of the desktop.
