Welch Allyn, Inc. 4341 State Street Road Skaneateles Falls, NY 13153 USA	<b>URGENT: Field Safety Notice          Follow-up</b>	<b>MOD1299R</b>
---	---	-----------------

Commercial name of affected product:

**Welch Allyn Patient Cables or Lead Sets**

Type of action: Device Recall

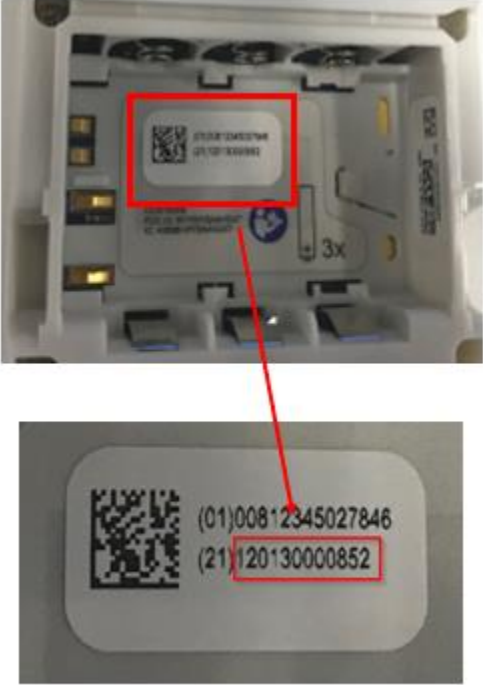
<p style="text-align: center;"><i>Figure 4: S4 Telemeter SN Label</i></p>	<p>S4-Q-AXX-XXX</p>

Device Marking	Part Numbers
