## Dringende Sicherheitsinformation

### **Modell A610 DBS-Arzt-Programmierer-App, Versionen 2.0.4584, 2.0.4594, 2.0.4605 und 3.0.1057**

Stimulationszyklus bei INS-Austausch und Anwendungsabsturzprobleme  
Softwareaktualisierung

#### **Medtronic Referenz: FA968 und FA969**

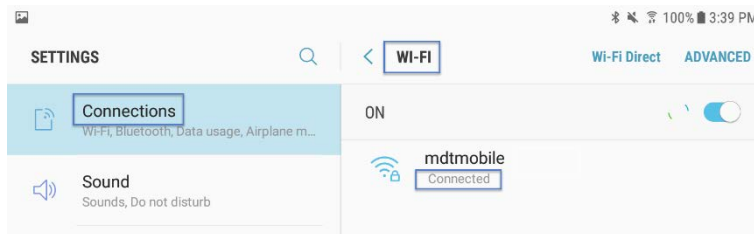
Settings
- Tap Connections > Wi-Fi > and select the desired Wi-Fi Network
- Verify it says "Connected"

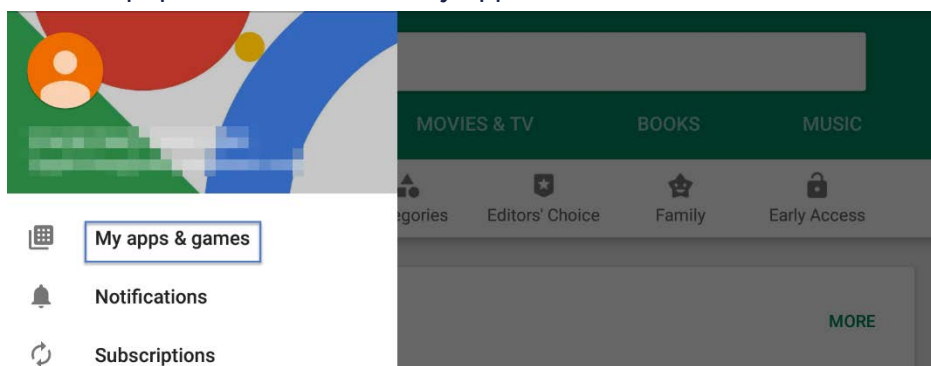
- Tap the menu icon next to the search bar

- From the pop-out menu, select "My Apps & Games"

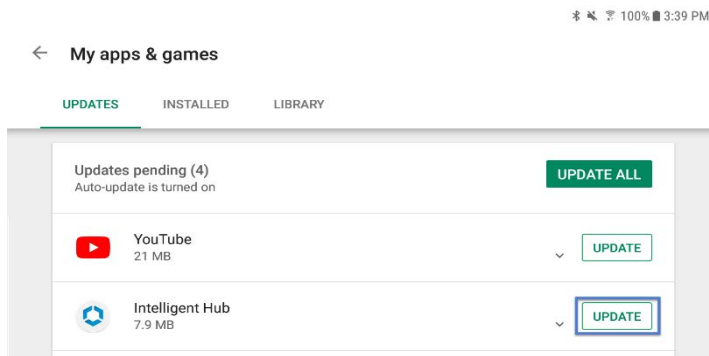
- c. Available updates will display. Update the “Intelligent Hub” app. This is the only necessary update and other apps can be updated later

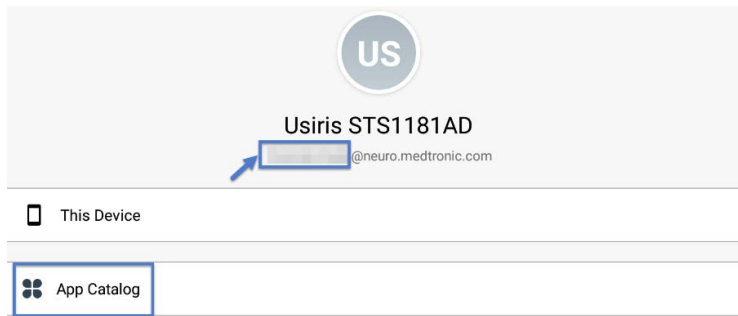
- a. The one-time welcome screen will display
- b. Notice that the tablet’s unique ID is in a different spot than it was in Agent
- c. Go to Hub and under This Device select Sync device. Wait approximately 1 minute to allow any changes to take place.
- d. Open “App Catalog”

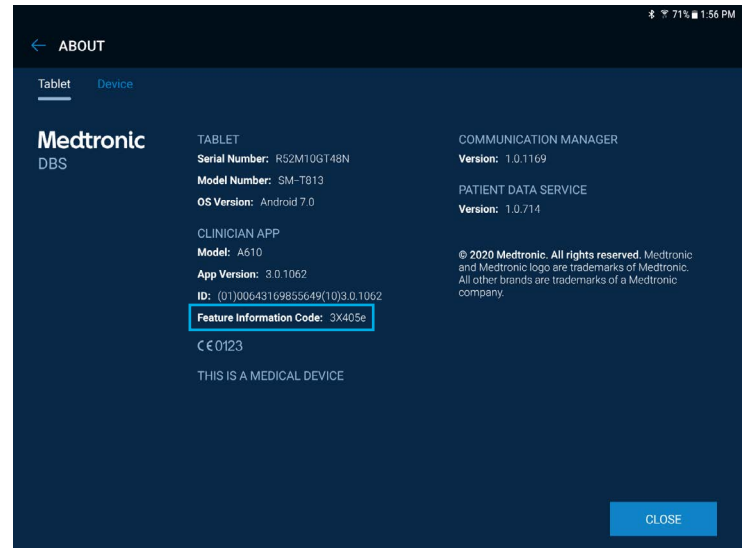
### ABOUT SCREEN

- Open the therapy application
- Tap the settings icon in the upper right and select "About"
- The version number will be displayed under "Clinician App"
- Important: Confirm feature code corresponds correctly with geography in the chart below.**

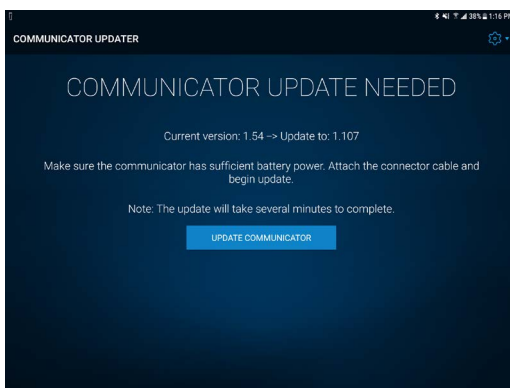
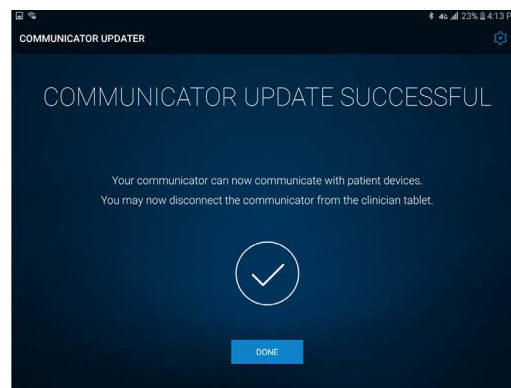
## Updating the CTM firmware

- Connect Communicator to the Tablet via USB cable**
- Select "Update Communicator"**
  - The update will begin and take several minutes to complete.
- Select "Done" on communicator update successful screen.**

**IMPORTANT! DO NOT** disconnect USB cable to power off the Tablet of the Communicator, until update progress is completed and "Communicator update successful" screen appears. During the update the LEDs of the Communicator will **NOT** be lit and the unit may appear non-functional.
