## Urgente Avviso di Sicurezza

### **Applicazione modello A610 del programmatore per il medico per la stimolazione cerebrale profonda (DBS) versioni 2.0.4584, 2.0.4594, 2.0.4605 e 3.0.1057**

Attivazione della modalità ciclica durante la sostituzione del neurostimolatore e crash dell'applicazione dopo interrogazione del neurostimolatore  
Aggiornamento software

#### **Riferimento Medtronic: FA968 & FA969**

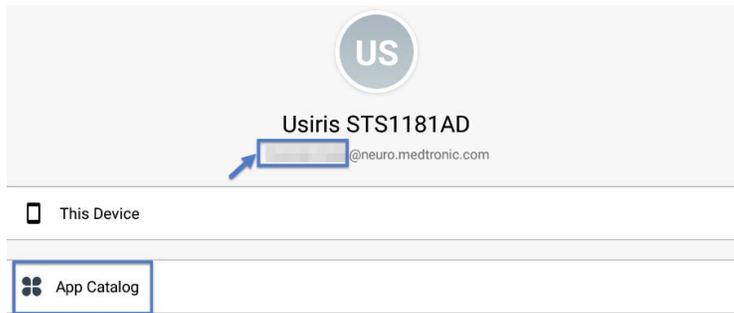
- a. The one-time welcome screen will display
- b. Notice that the tablet’s unique ID is in a different spot than it was in Agent
- c. Go to Hub and under This Device select Sync device. Wait approximately 1 minute to allow any changes to take place.
- d. Open “App Catalog”

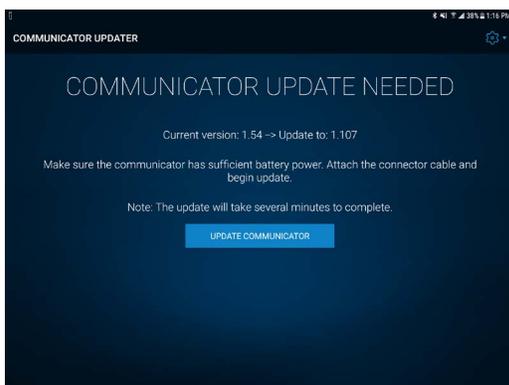
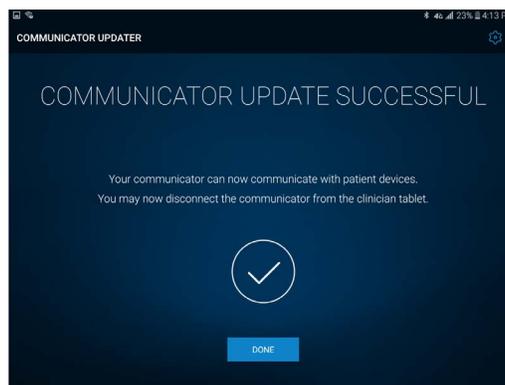
## Updating the CTM firmware

You may be prompted to update the firmware of the communicator the first time you try to connect.

- Connect Communicator to the Tablet via USB cable**
- Select "Update Communicator"**
  - The update will begin and take several minutes to complete.
- Select "Done" on communicator update successful screen.**

**IMPORTANT! DO NOT** disconnect USB cable to power off the Tablet of the Communicator, until update progress is completed and "Communicator update successful" screen appears. During the update the LEDs of the Communicator will **NOT** be lit and the unit may appear non-functional.
