# FIELD SAFETY NOTICE ALERT

# **Team3 Fetal Monitor**

Resolution in summary:	Upgrade Fetal Monitor with revised software (v19.4)
No pages:	15 inclusive of the declaration form

#### FSN01-23

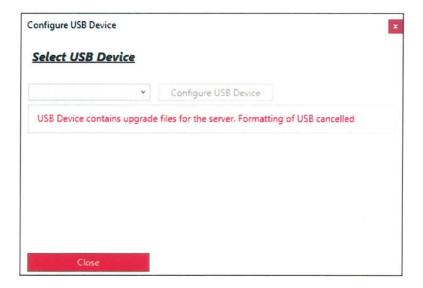
If the USB memory stick contains log files created during an upgrade operation, the following message is displayed when trying to write the upgrade files:

In this case, close the dialog box and replace the USB stick to before trying again.
