FIELD SAFETY NOTICE ALERT

Team3 Fetal Monitor

Resolution in summary:	Upgrade Fetal Monitor with revised software (v19.4.1)
No pages:	15 inclusive of the declaration form

FSN01-23 Rev 2

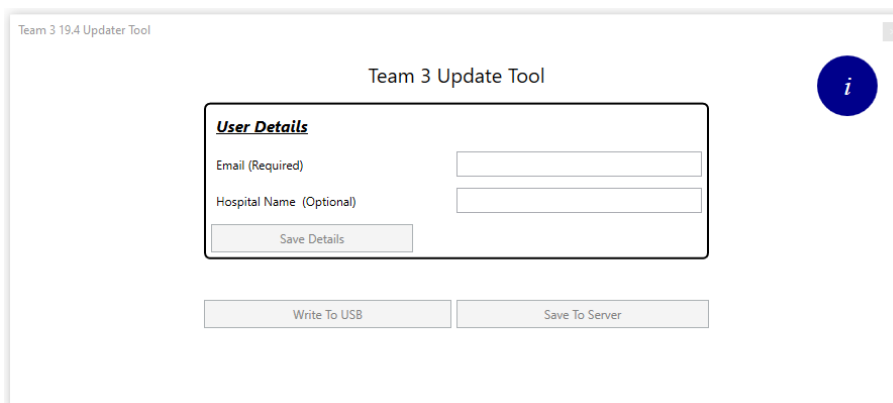
The following main screen will be displayed. Note that on first run, all of the control buttons are greyed out and unavailable. This will be the case until a valid email address is entered in the appropriate field.

- Enter a valid email address – the 'Save Details' button becomes available
- Optionally enter hospital details and click on 'Save Details' button
- Click on 'Write To USB' button which is now available
