URGENT Field Safety Notice

Spectral CT 7500 with software version 5.0.0.X
Software issues with a potential to cause misdiagnosis, CT rescan, or burning smell and smoke

November 30, 2023

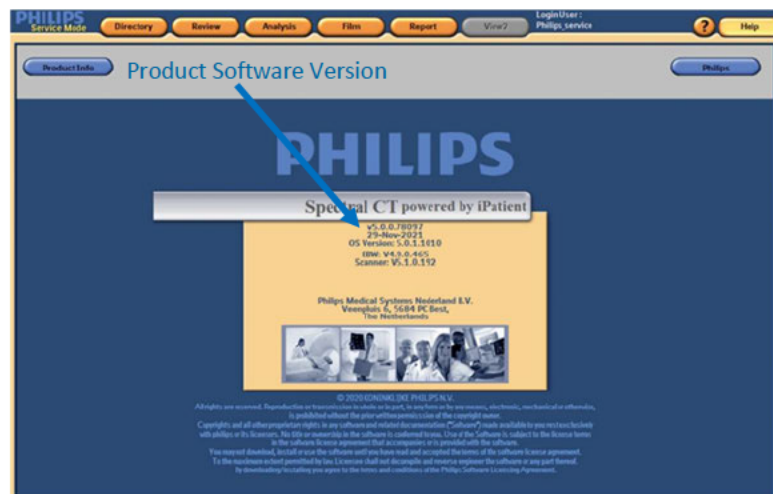
Figure 2. Spectral CT 7500 Software version shown as an example

1. Navigate to the Home screen and click the **Help** button.
2. Select **About** and the software version is then displayed as shown in Figure 2. The software version begins with **v**.

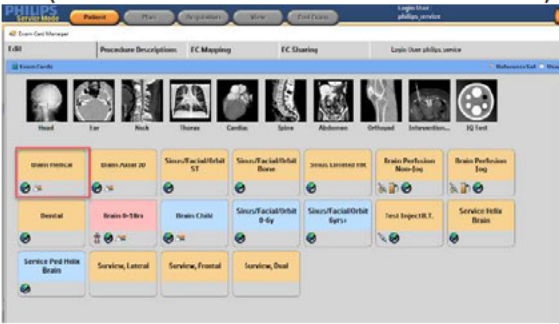
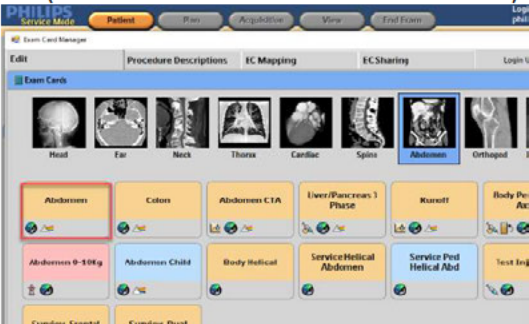
4) Select the Exam Card that you want to edit (Brain Helical is shown below for illustration).	4) Select the Exam Card that you want to edit (Abdomen is shown below for illustration).

To change the collimation, follow the steps below: 1) for the Brain scan and 2) for the Body scan.
