**URGENT Field Safety Notice**

Trilogy Evo, Trilogy Evo O2, Trilogy EV300  
Loss of Power Alarm – Software Correction Update

18-APR-2024

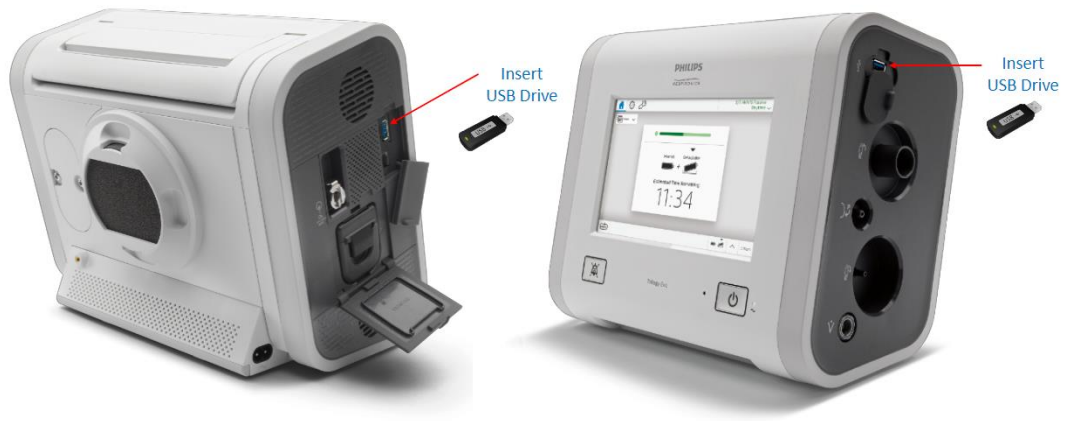
1. Insert the USB-drive in any of the two USB ports of your device.

2. Go to the OPTIONS window (wrench icon) > Data Transfer
3. The device will recognize the USB drive and will show the Software version on the “Install Software Update” box. Click on that box.
4. Confirm that you are upgrading the device to the latest version and click YES
5. Trilogy Evo is now installing the new software. Please, wait.
6. A confirmation of Software installation complete will be shown. Press OK and turn the ventilator ON.

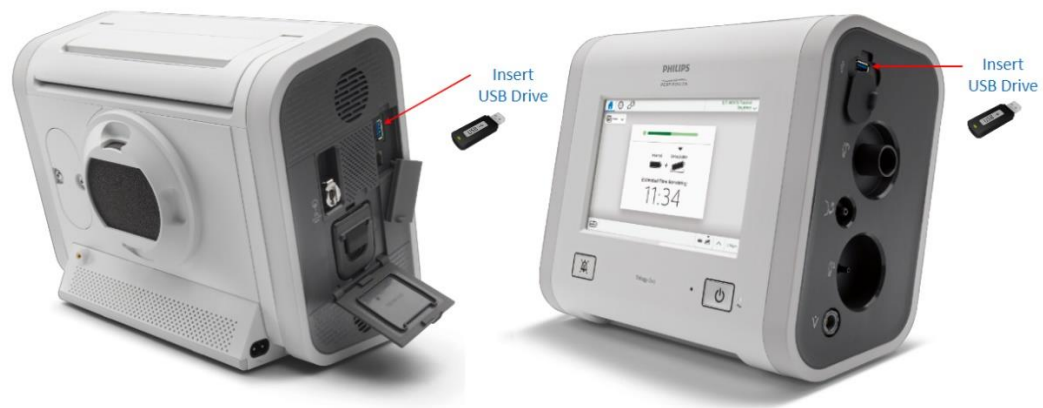
1. Insert the USB-drive in any of the two USB ports of your device.

2. Go to the OPTIONS window (wrench icon) > Data Transfer
3. The device will recognize the USB drive and will show the Software version on the “Install Software Update” box. Click on that box.
4. Confirm that you are upgrading the device to the latest version and click YES
5. Trilogy Evo is now installing the new software. Please, wait.
6. A confirmation of Software installation complete will be shown. Press OK and turn the ventilator ON.
