## Field Safety Notice

### Urgent Medical Device Notification – ISIFA2018-04-C

*da Vinci Xi*® Stapler 45 Blue and Green Reloads Missing Knife Component

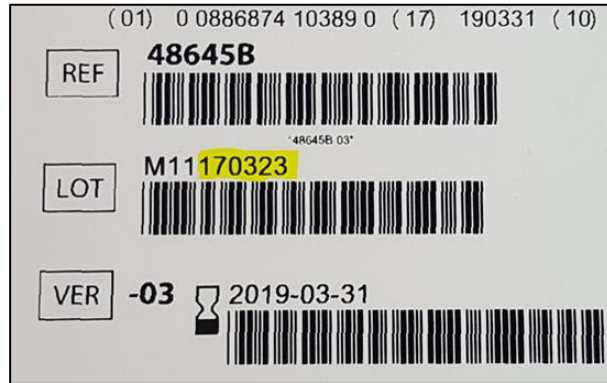
Figure 1: Affected Lot of Xi Stapler 45 Reloads

For your reference, lots that fall within the referenced lot ranges below may be affected by this issue. You can locate the affected lot number on the reload packaging by identifying only the last 6 digits. See Figure 1:
