## URGENT FIELD SAFETY NOTICE

GEHC Ref# 30085

**RE: T2100 Treadmill Uncontrolled Walking Belt Motion – Customer Owned Spare Parts**

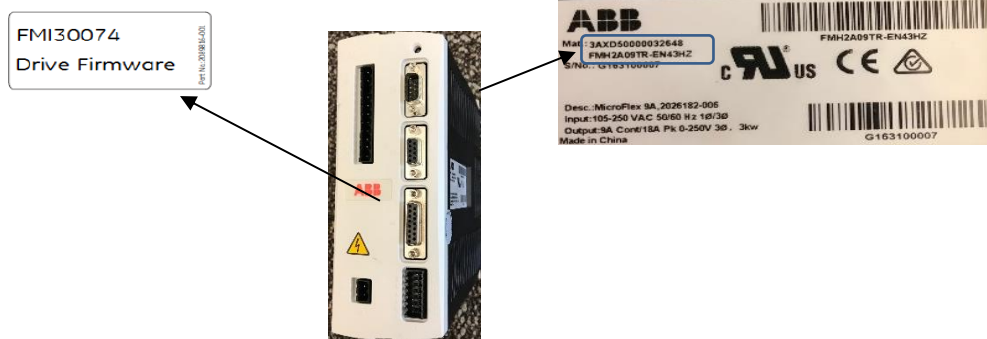
1) If your spare part drive has a FMI 30074 correction label attached (see below picture) or GE part number (2026182-006) ABB part number (3AXD50000032648, 3AXD50000032647 or FMH2A09TR-EN43HQ), the firmware on the drive was updated and your spare part is not affected. No further action is required except to **complete and return** the attached “Customer Response” form checking box #1 to indicate that you **do not** have affected spare part inventory and e-mail to [DCAR.30085@ge.com](mailto:DCAR.30085@ge.com).

FMI correction label

Firmware

ABB part number label

Note: The spare part packaging is labeled with the GE part number and the Microflex drive is labeled with the ABB part number.

2) If your spare part drive **does not** have the FMI correction label attached and is GE part number (2026182-002 or 2026182-004) ABB part number (FMH2A09TR-EN43EQ, FMH2A09TR-EN43E, FMH2A09TR-EN43E/12 or FMH2A09TR-EN43GZ), the firmware on the drive was not updated and you have affected spare part inventory. No further action is required regarding your spare part drive except to **complete and return** the attached “Customer Response” form checking box #2 to indicate that you **do** have affected spare part inventory and e-mail to [DCAR.30085@ge.com](mailto:DCAR.30085@ge.com).

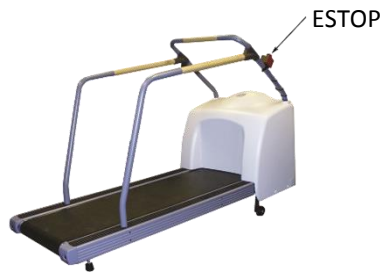
- Depress the Emergency Stop (ESTOP) button completely so that it locks

- If the Emergency Stop (ESTP) button does not stop treadmill motion, unplug the power cord from the wall outlet.
- Instruct the patient to:
  - Hold the handrails to help maintain balance
  - Step off the walking belt by placing their feet on the rubberized non-skid surfaces on either side of the walking belt
  - After the walking belt coasts to a complete stop, instruct the patient to step off the treadmill. Depending on belt speed, a full stop may take up to 35 seconds.

**WARNING:** While the emergency stop switch is depressed or when power is not applied to the treadmill, the walking belt is not locked. The walking belt in this condition is allowed to move which could cause a person to lose balance and fall while standing on the belt. Note, the risk of belt movement is increased with higher treadmill grades or inclines.
