URGENT - Field Safety Notice

Hardware update of Patient Support (12NC 989001087431)

FSN MA-FCO 71200185

July 2018

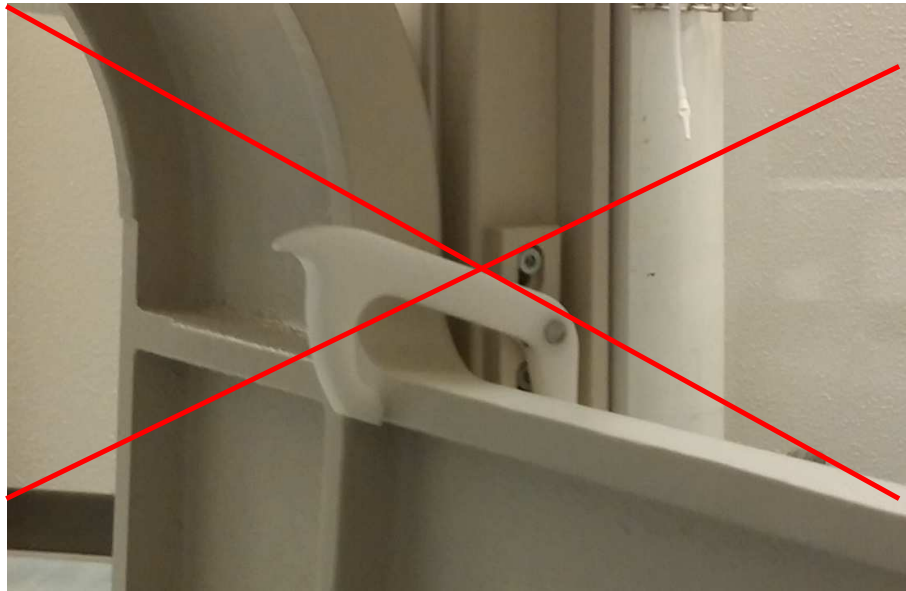
AFFECTED PRODUCTS	Patient support (NC989001087431)
PROBLEM DESCRIPTION	<p>The footplate of the Patient support for stitching can be fixed in upper position. When the fixing clamp (hook) is not in its correct looking position, the footplate is not securely held. If it falls down, it may hurt the operator's or patient's foot or leg (e.g. when moving the stand or when the operator fails to fix it correctly upon moving the footplate up).</p> <p>Following factors are needed that the situation occurs:</p> <ul style="list-style-type: none"> • Hinges are worn differently on both sides • Hook does not hold • Operator does not check that the hook securely holds the footplate • Footplate falls unexpectedly when touched or during transport • Foot or leg in "target area" • Foot in "hazard area"
HAZARD INVOLVED	The hook does not securely hold the footplate in vertical position. Therefore, the footplate can fall or swing down and may hurt the operator or patient.

The customer / user should always check the right position of the hook and that the hook is locked according to IfU. (Press hook down until it is locked) Make sure that the hook is in position as shown in the picture with the green arrow

ACTIONS PLANNED BY PHILIPS	<p>Philips plans to redesign the:</p> <ul style="list-style-type: none">• sturdier replacement hinges for floor plate• install modified hook for floor plate (adapted to new hinges)• brake cylinder below floor plate to minimize kinetic energy <p>A Philips Service Engineer will contact you as soon as the Field Action Kit is ready to be implemented.</p> <p>Should you need to communicate with Philips in regards to this program, please reference FCO-71200185.</p>
FURTHER INFORMATION AND SUPPORT	<p>If you need any further information or support concerning this issue, please contact your local Philips representative:</p> <p>0800 80 3000</p>
